2016 Delineation of Hydrilla and other Submersed Aquatic Vegetation (SAV) in the Croton River: Black Rock Park

12/15/2016

*Croton River: Black Rock Park
Village of Croton-on-Hudson, Westchester County, New York*

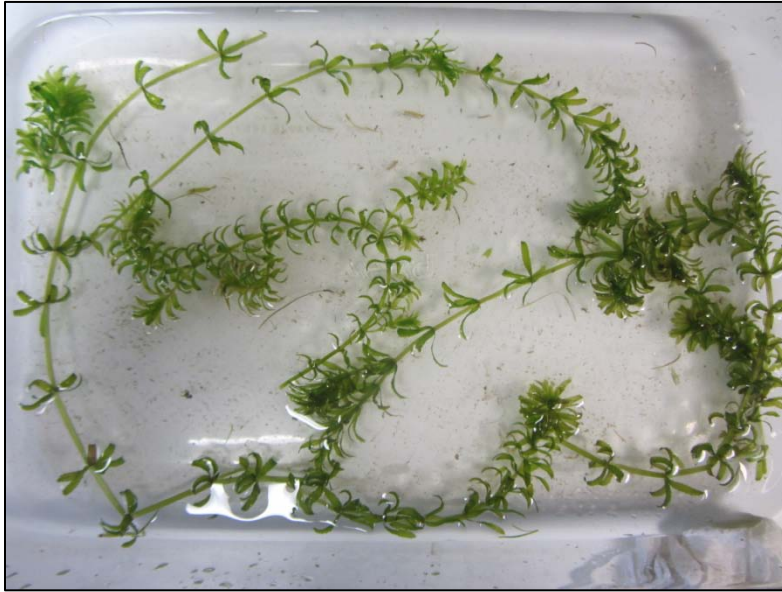
Hydrilla (*Hydrilla verticillata*)
Common Name: Hydrilla, waterweed. **Exotic, aggressive, Invasive.**) : Hydrilla is native to parts of Asia, and was introduced to the Northeast region in the mid-1900's. Hydrilla is the perfect weedy species, able to outcompete desirable native species due to an array of adaptations. These include growing in a variety of substrates, moving or still waters, tolerating up to 10 ppt salinity, and adept at low-light growth. It is typically rooted in

the substrate, but can persist in drifting mats. Although similar to common waterweed, hydrilla has strongly serrated leaves (visible with the naked eye), and have a barbs on the underside of the midrib. The leaves are typically arranged in whorls of 4 to 8, but lower parts of the plant can be in whorls of three, or even opposite in arrangement. Hydrilla readily reproduces via stem fragmentation, and produces turions and hardy tubers to overwinter. Two distinct forms occur in the Northeast: monoecious (generally found in the north) and dioecious (generally more robust and found in southern climes).

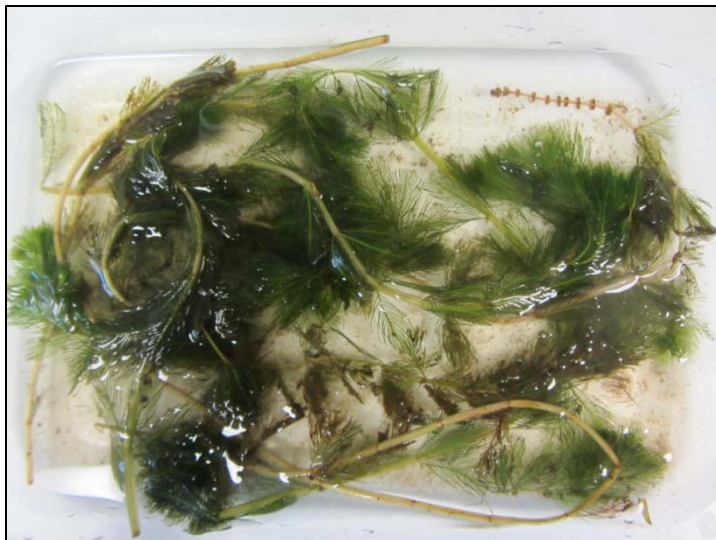
Eurasian Water Milfoil (*Myriophyllum spicatum*. Common Names: Asian Water milfoil. **Aggressive, Exotic, Invasive.**): Eurasian water milfoil has long (2 meters or more) spaghetti-like stems that grow from submerged rhizomes. The stems often branch repeatedly at the water's surface creating a canopy that can crowd out other vegetation, and obstruct recreation and navigation. The leaves are arranged in whorls of 4 to 5, and spread out along the stem. The leaves are divided like a feather, resembling the bones on a fish spine. Eurasian

water milfoil is an exotic originating in Europe and Asia, but its range now includes most of the United States. It's ability to grow in cool water and at low light conditions gives it an early season advantage over most other native submersed plants. Although it can reproduce via fruit production, it typically also reproduces via fragmentation.

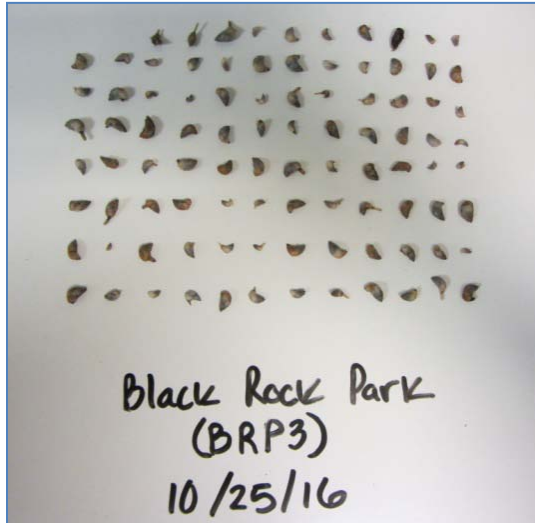
The tuber density ranged from 498.4 tubers per m² to 1,904.6 tubers per m². Turion density ranged from 0.0 turions per m² to 53.4 turions per m². However, only two sites had turions (BRP-1 and BRP-3). The lowest tuber density was collected along the east shore by the concrete structure. The water here was deeper, and the sediment was rocky. The highest tuber density was along the west shore, north of the concrete structure. Abundant hydrilla growth occurred in this area, and during the SAV mapping hydrilla produced flowers in this area. The picture to the left depicts the tubers collected at BRP-3 on October 25th.

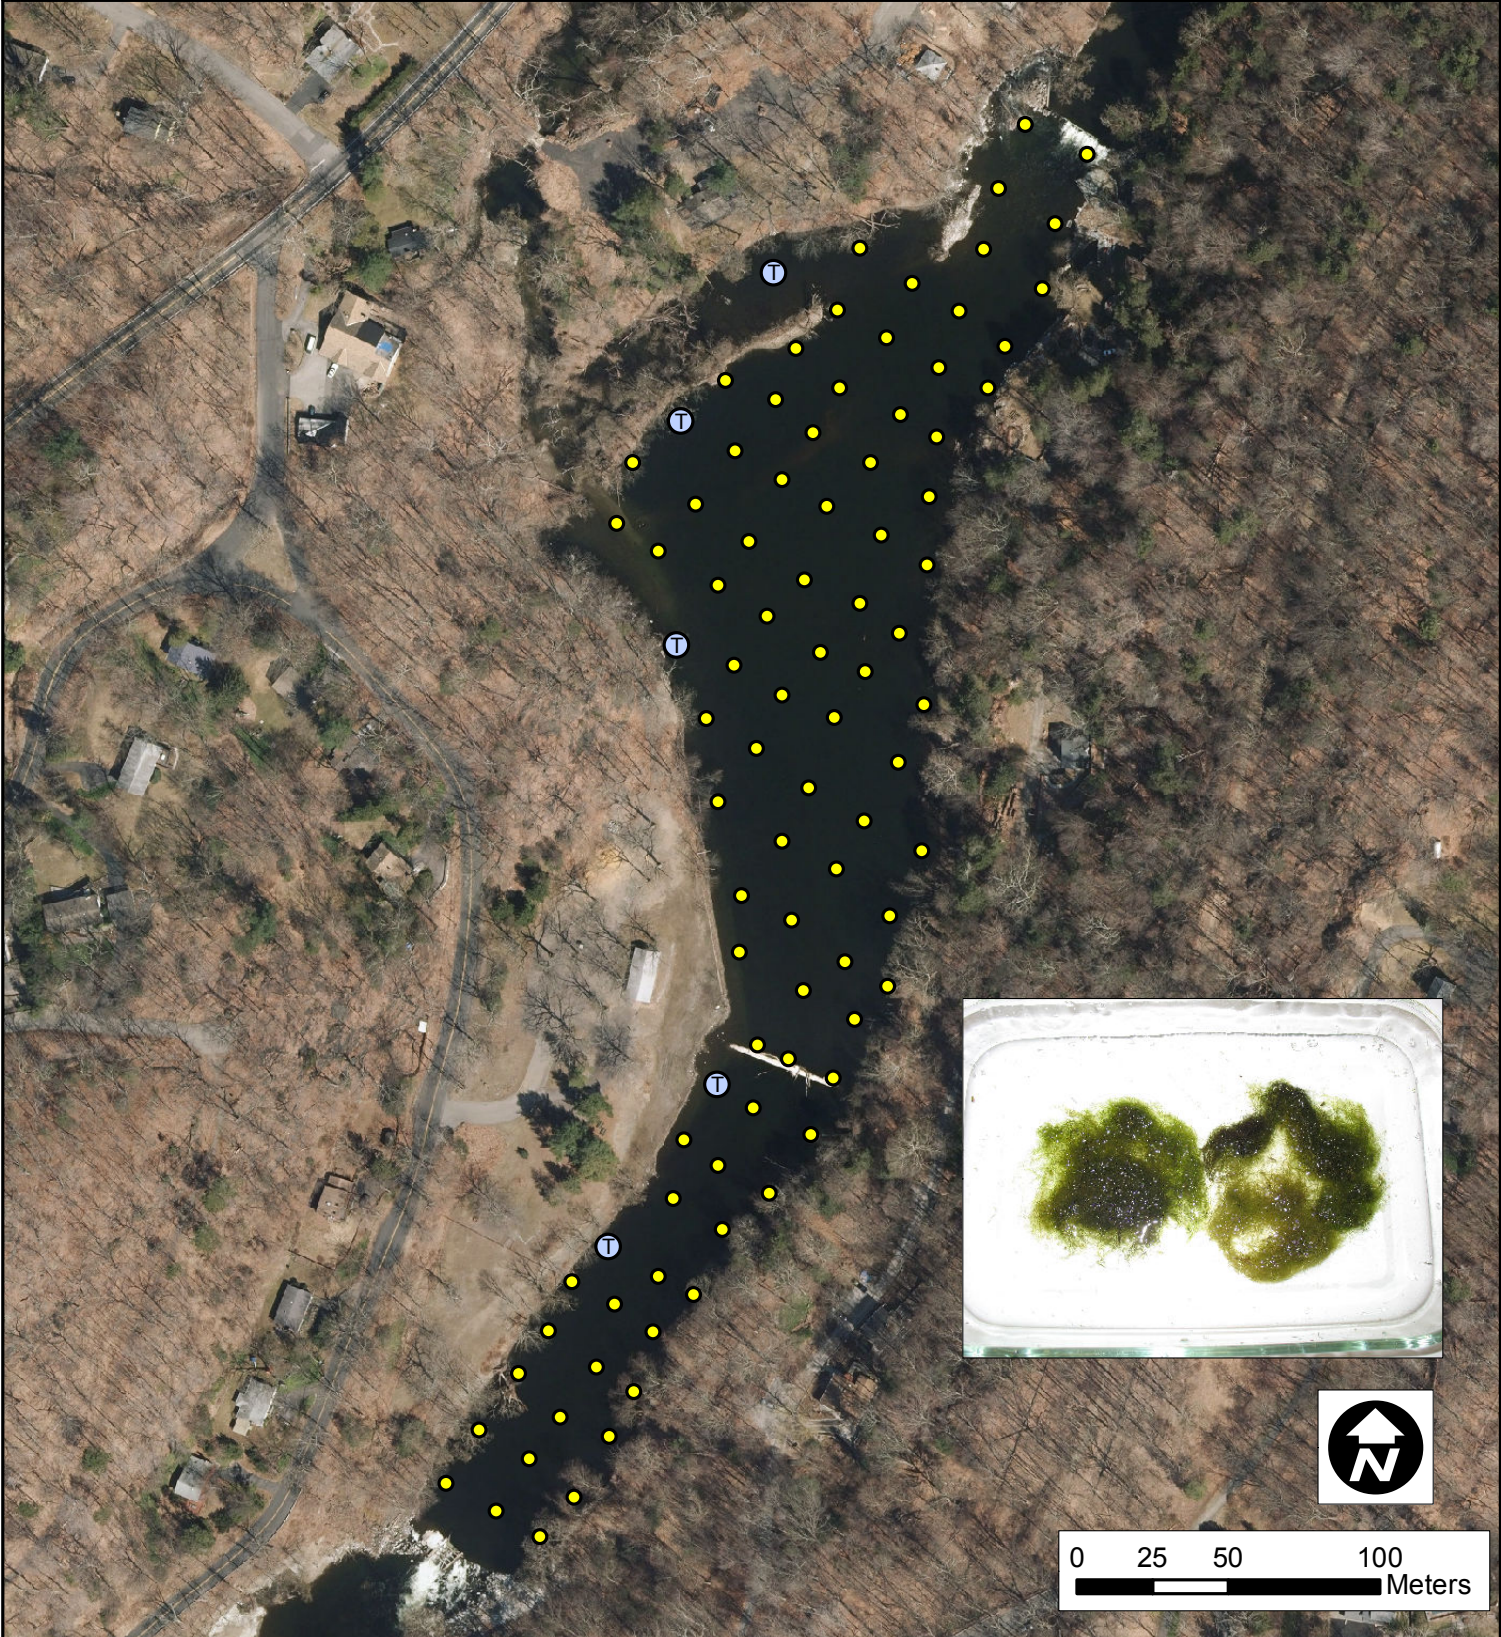
Benthic Filamentous Algae Distribution

Croton River
Section A- Black Rock Park
Aquatic Vegetation Survey
October 04, 2016
 93 Sites

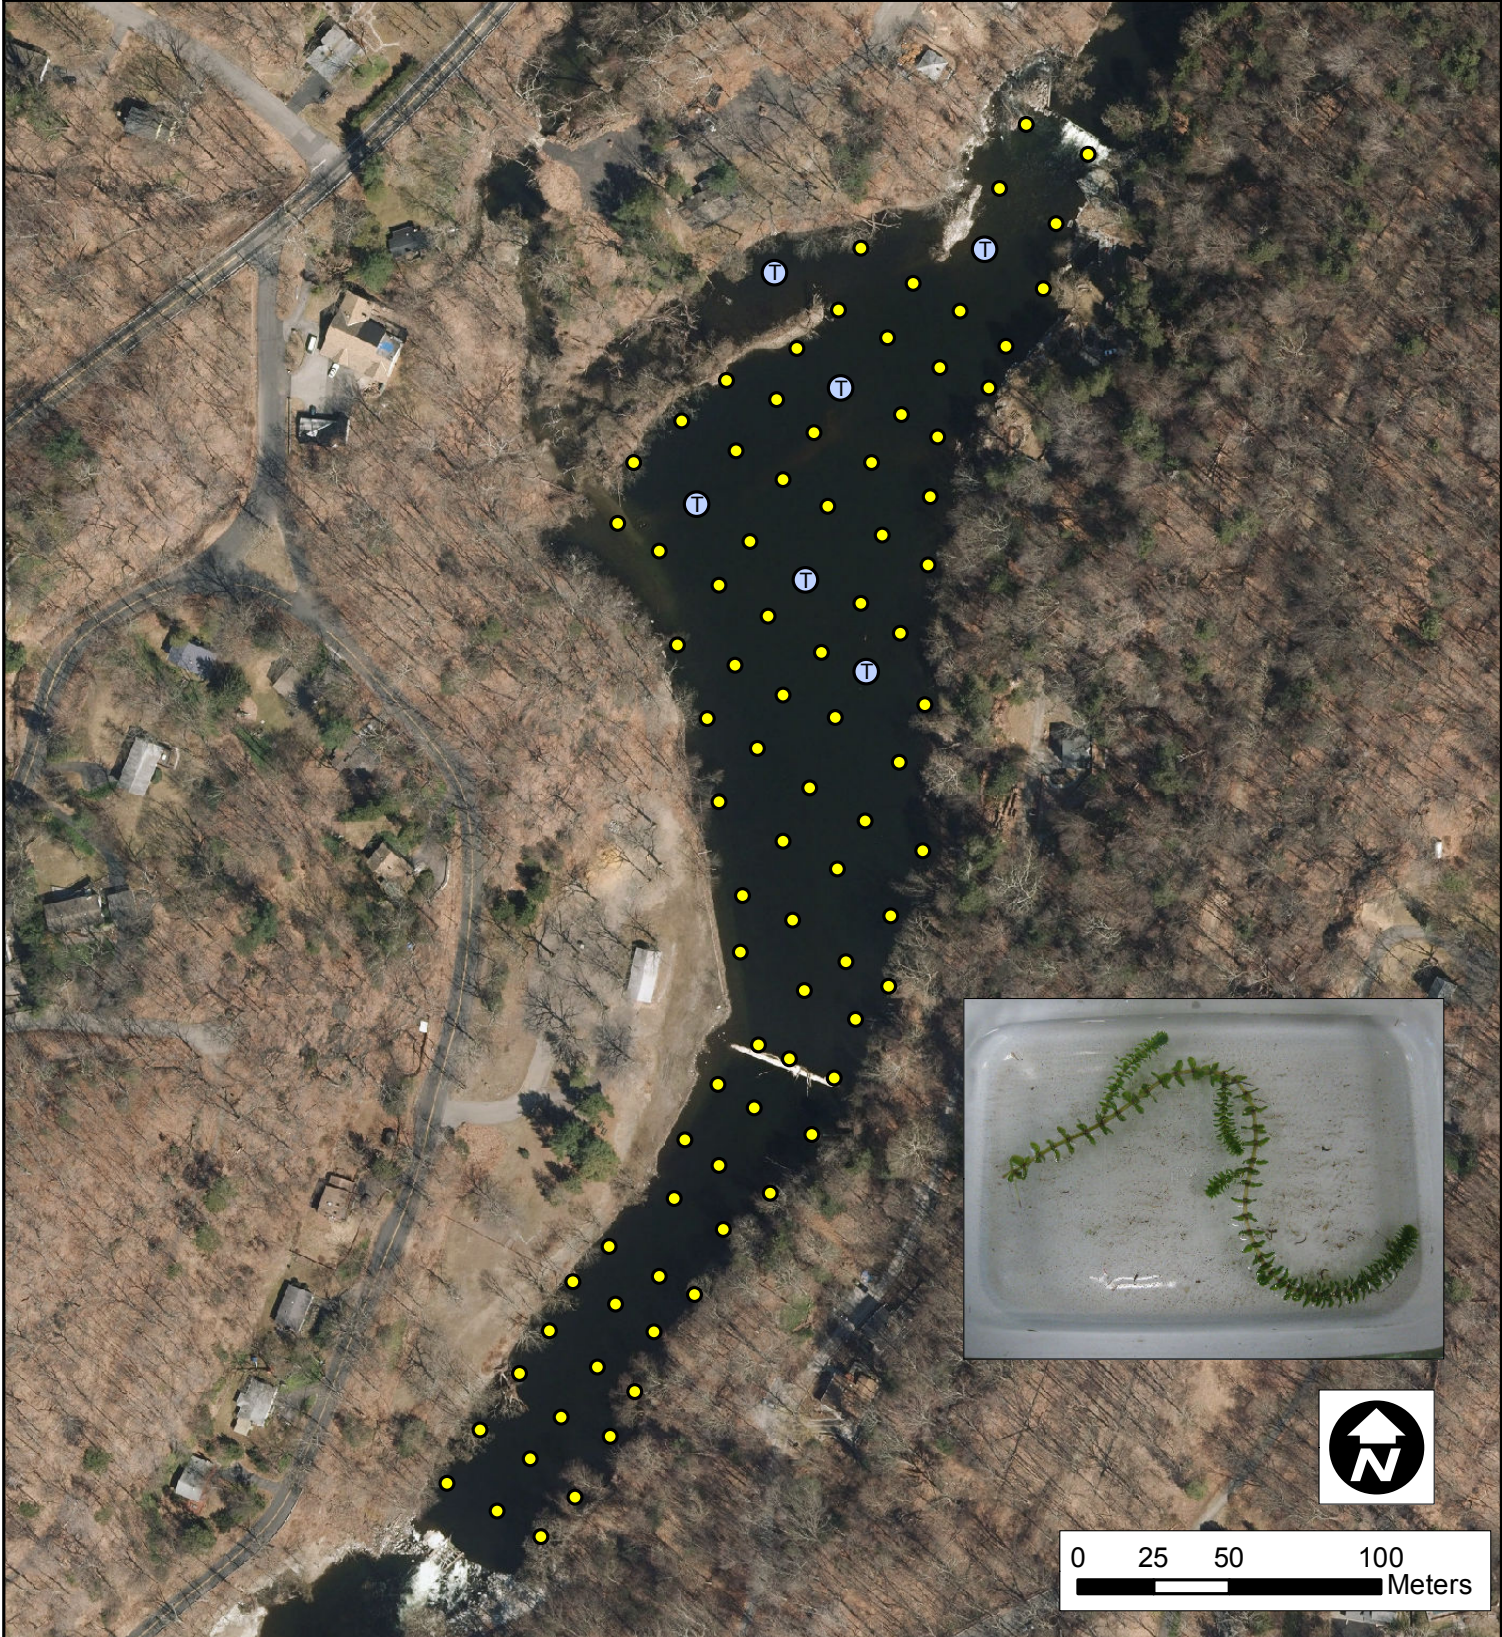
**Common Waterweed (*Elodea canadensis*)
Distribution**

**Croton River
Section A- Black Rock Park
Aquatic Vegetation Survey
October 04, 2016
93 Sites**

Percent Distribution	Abundance	Sites	Percent
	Total	6	6%
Trace	6	100%	
Sparse	0	0%	
Medium	0	0%	
Dense	0	0%

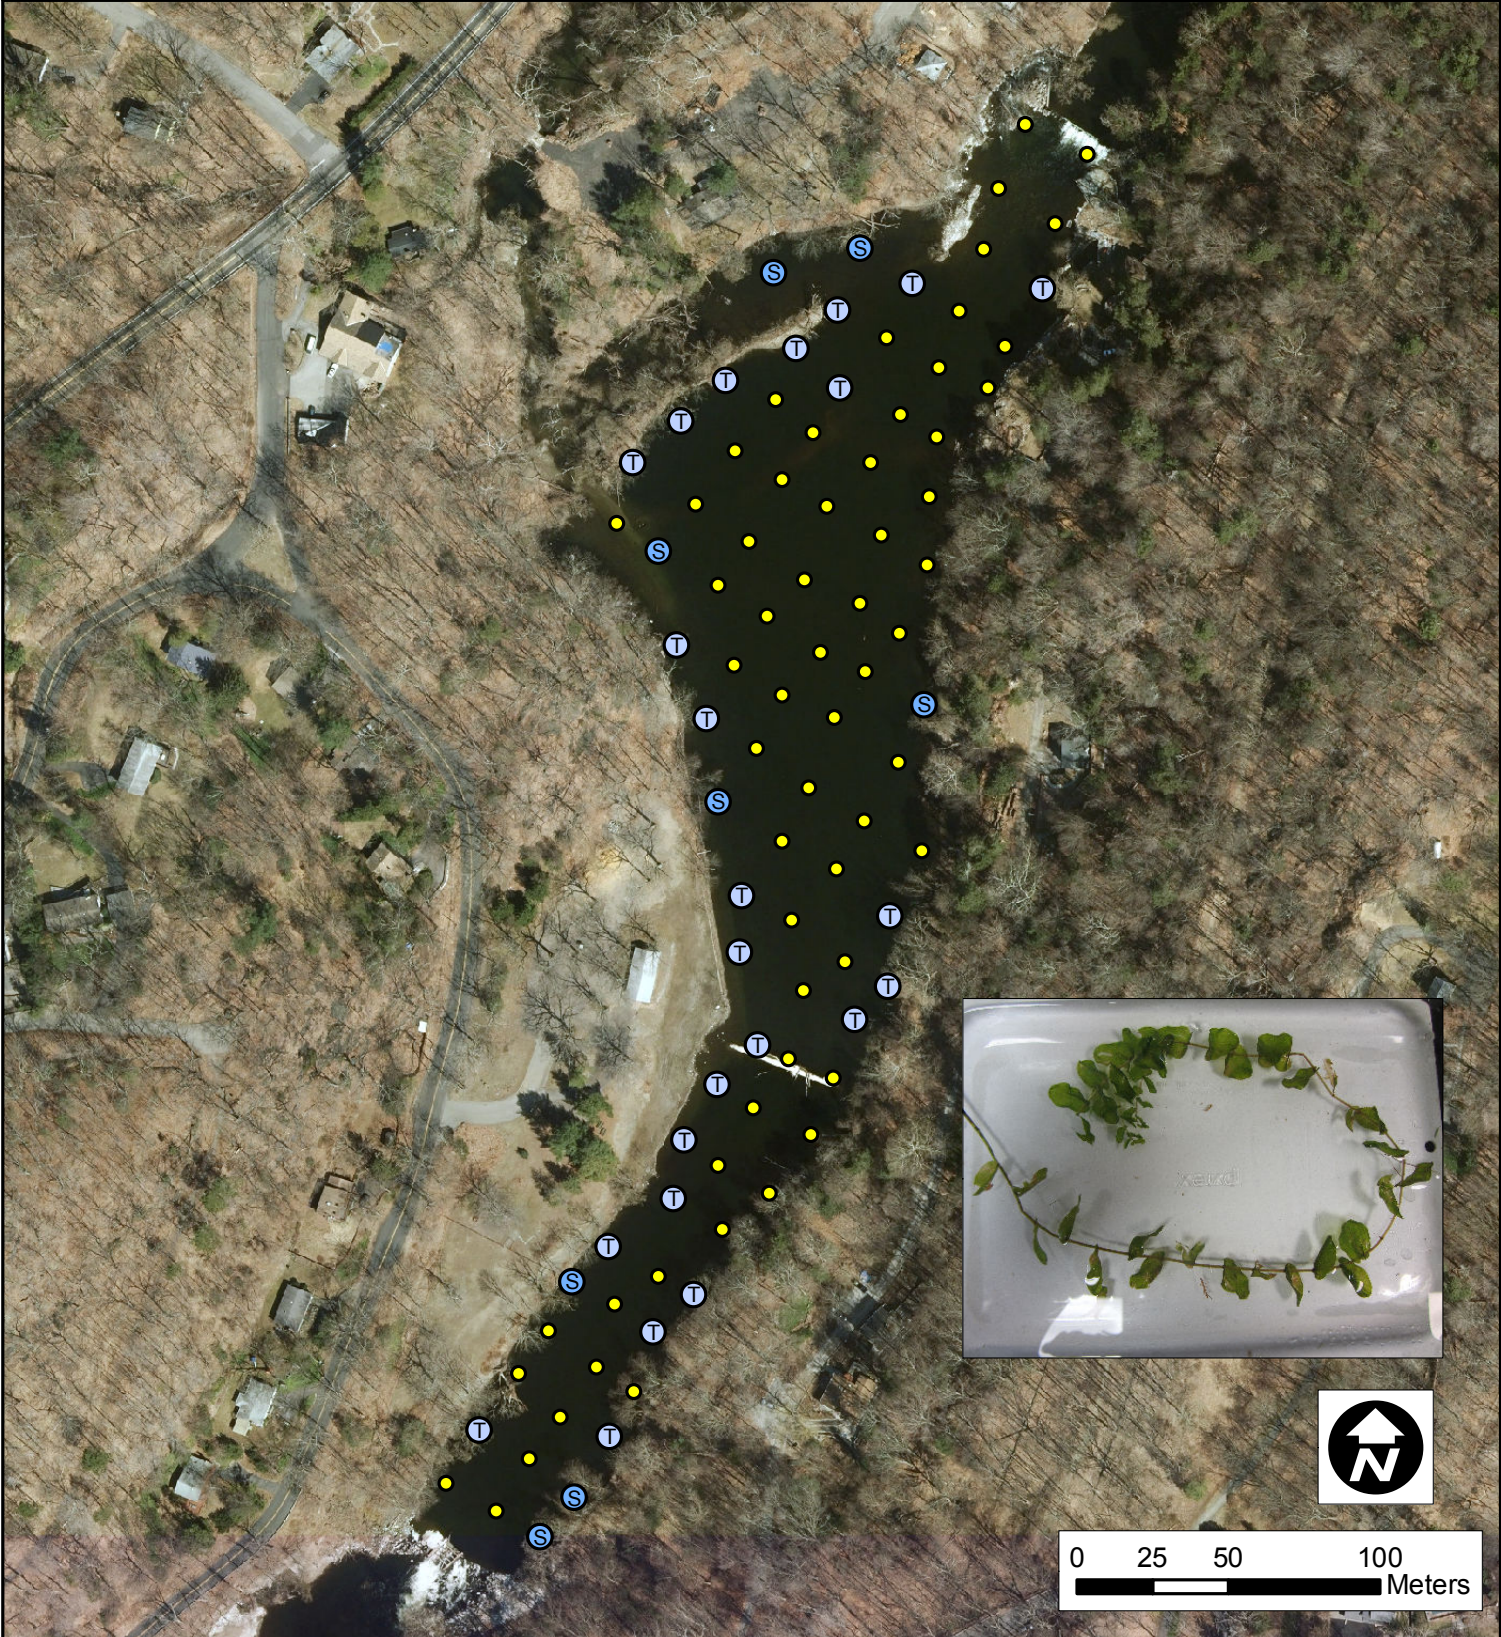
Heart Pondweed (*Potamogeton perfoliatus*) Distribution

Croton River
Section A - Black Rock Park
Aquatic Vegetation Survey
October 04, 2016
 93 Sites

The next two native species occurred at a much reduced abundance compared to the two invasive species discussed above. Heart pondweed (*P. perfoliatus*) occurred at 32 (or 34%) of the sites and coontail occurred at 25 (or 27%) of the sites surveyed. Both had similar abundance in July 2016, but coontail only occurred at 17% of the sites in 2014. All heart pondweed sites were considered trace and sparse density, and generally were restricted to shallow water shoreline sites. Coontail typically occurred at trace or sparse density, but one dense site was collected. In the upper part of the basin, coontail generally preferred open water sites.

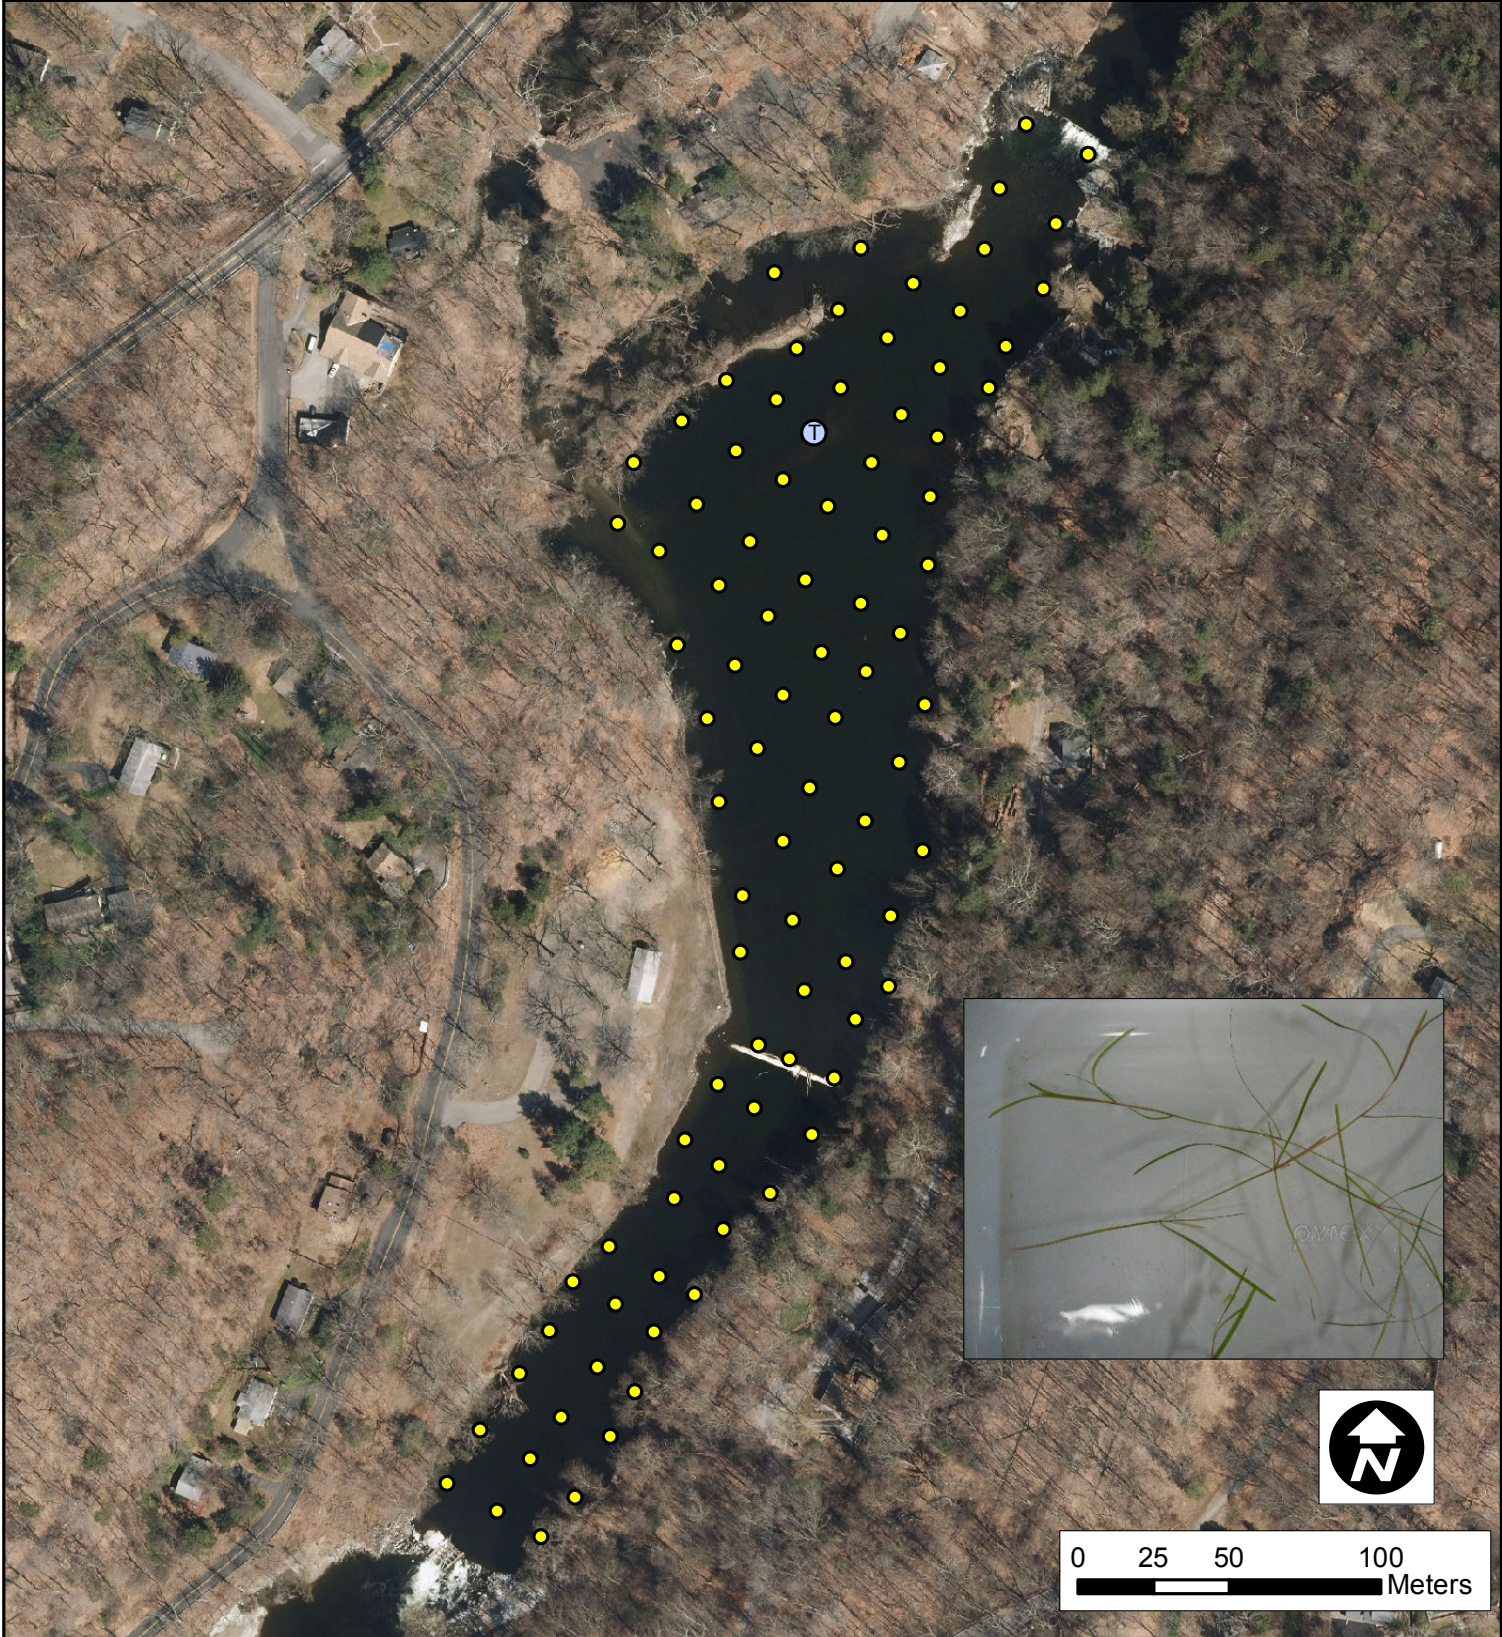
Leafy Pondweed (*Potamogeton foliosus*) Distribution

Croton River
Section A - Black Rock Park
Aquatic Vegetation Survey
October 04, 2016
 93 Sites

Percent Distribution	Abundance	Sites	Percent
	Total	1	1%
	Trace	1	100%
	Sparse	0	0%
	Medium	0	0%
	Dense	0	0%

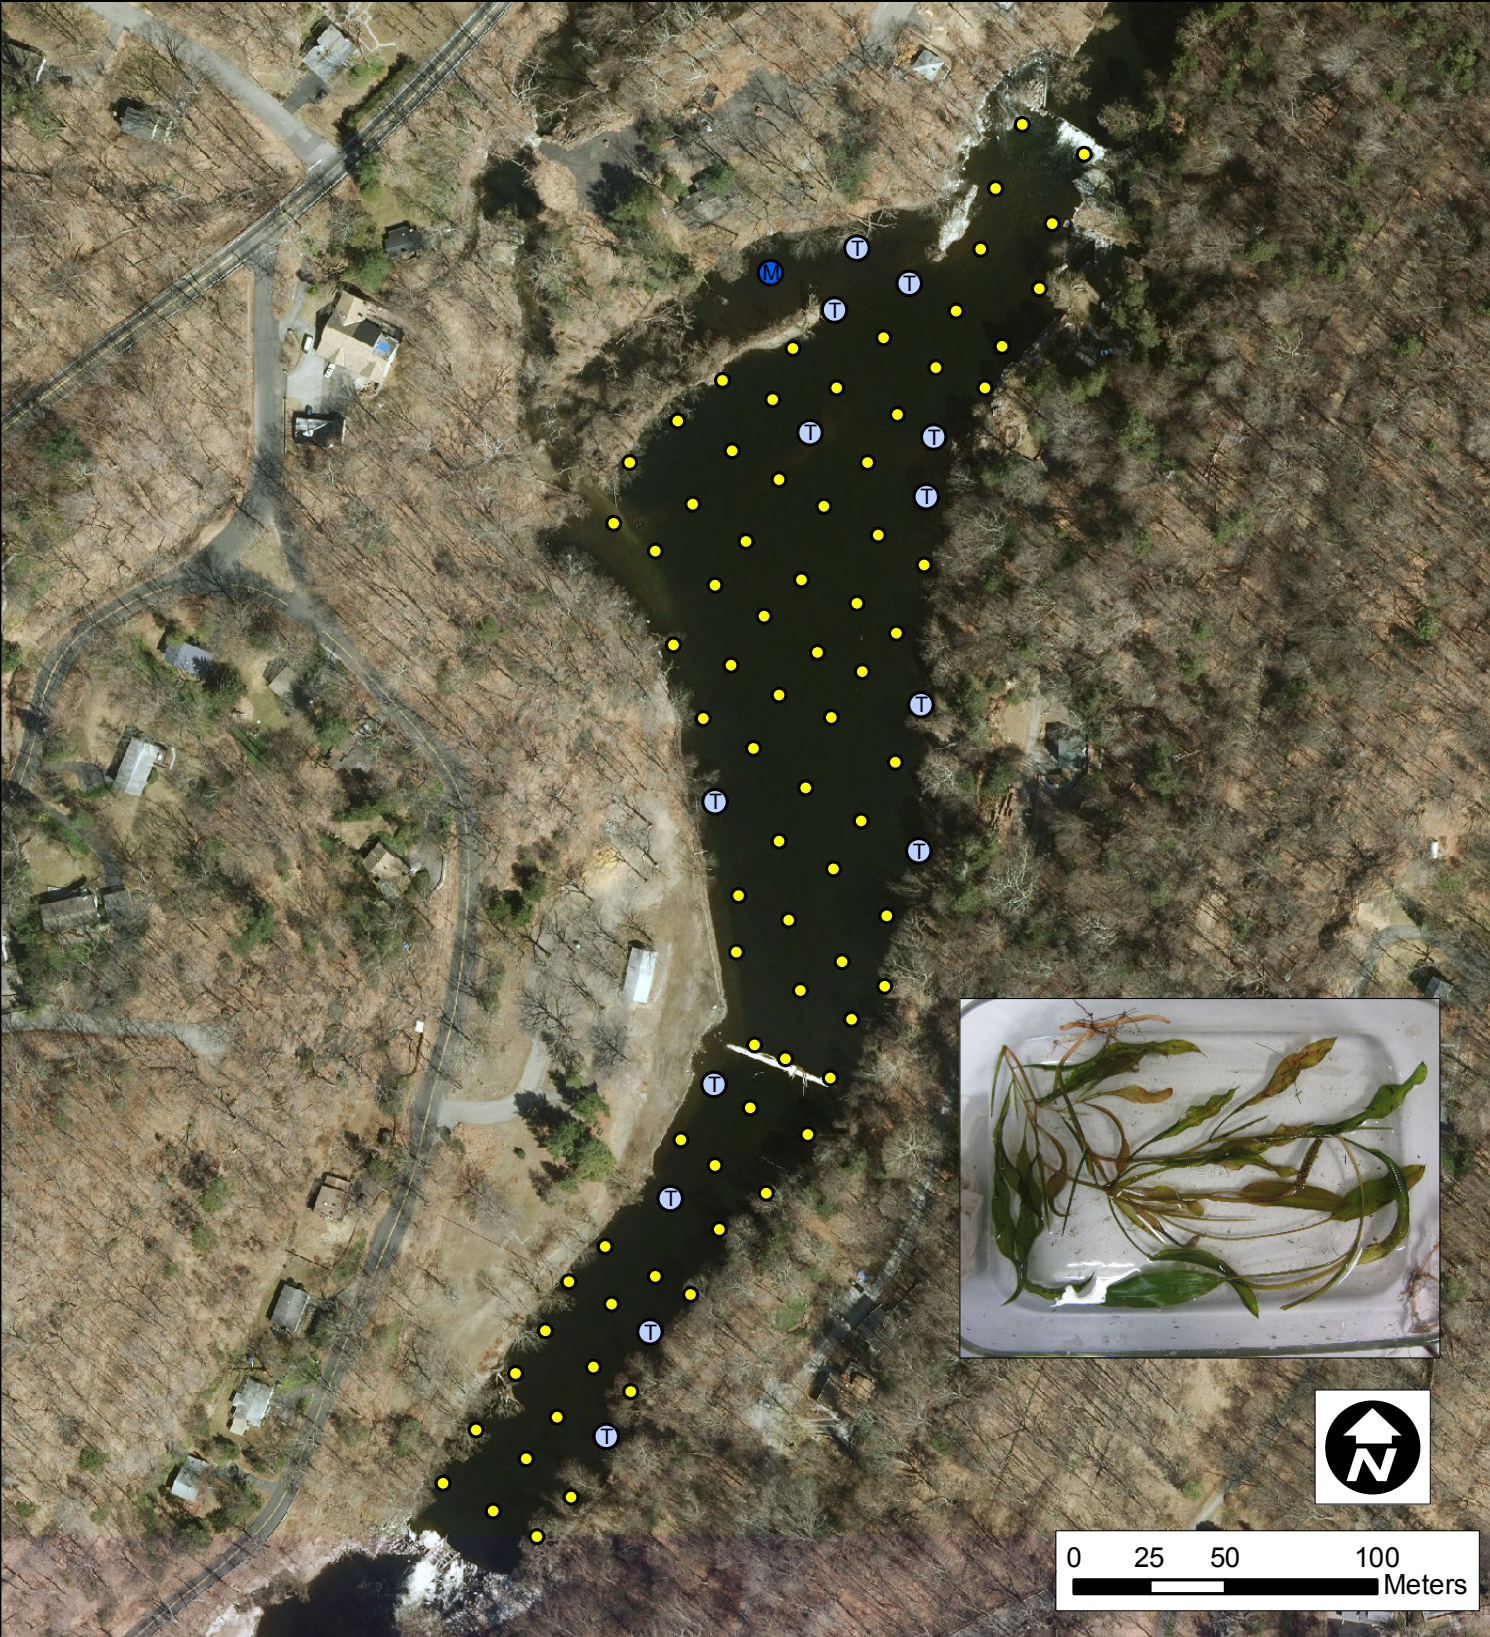
Long-leaf Pondweed (*Potamogeton nodosus*) Distribution

Croton River
Section A - Black Rock Park
Aquatic Vegetation Survey
October 04, 2016
 93 Sites

Percent Distribution	Abundance	Sites	Percent
	Total	14	15%
Trace	13	93%	
Sparse	0	0%	
Medium	1	7%	
Dense	0	0%

Long-leaf pondweed (14, or 15%), Sago pondweed (9 sites, or 10%) curly-leaf pondweed (8 sites, or 9%) and common waterweed (6 sites, or 6%) were also observed. All of these are desirable native species save for curly-leaf pondweed. Typically, all these species occurred at trace density. It is possible that common waterweed abundance and distribution was underestimated at this location due to the prolific growth of hydrilla, as it is difficult to distinguish both of these plants in the field. Benthic filamentous algae occurred at 5 (or 5%) of the sites, and were all considered trace abundance.

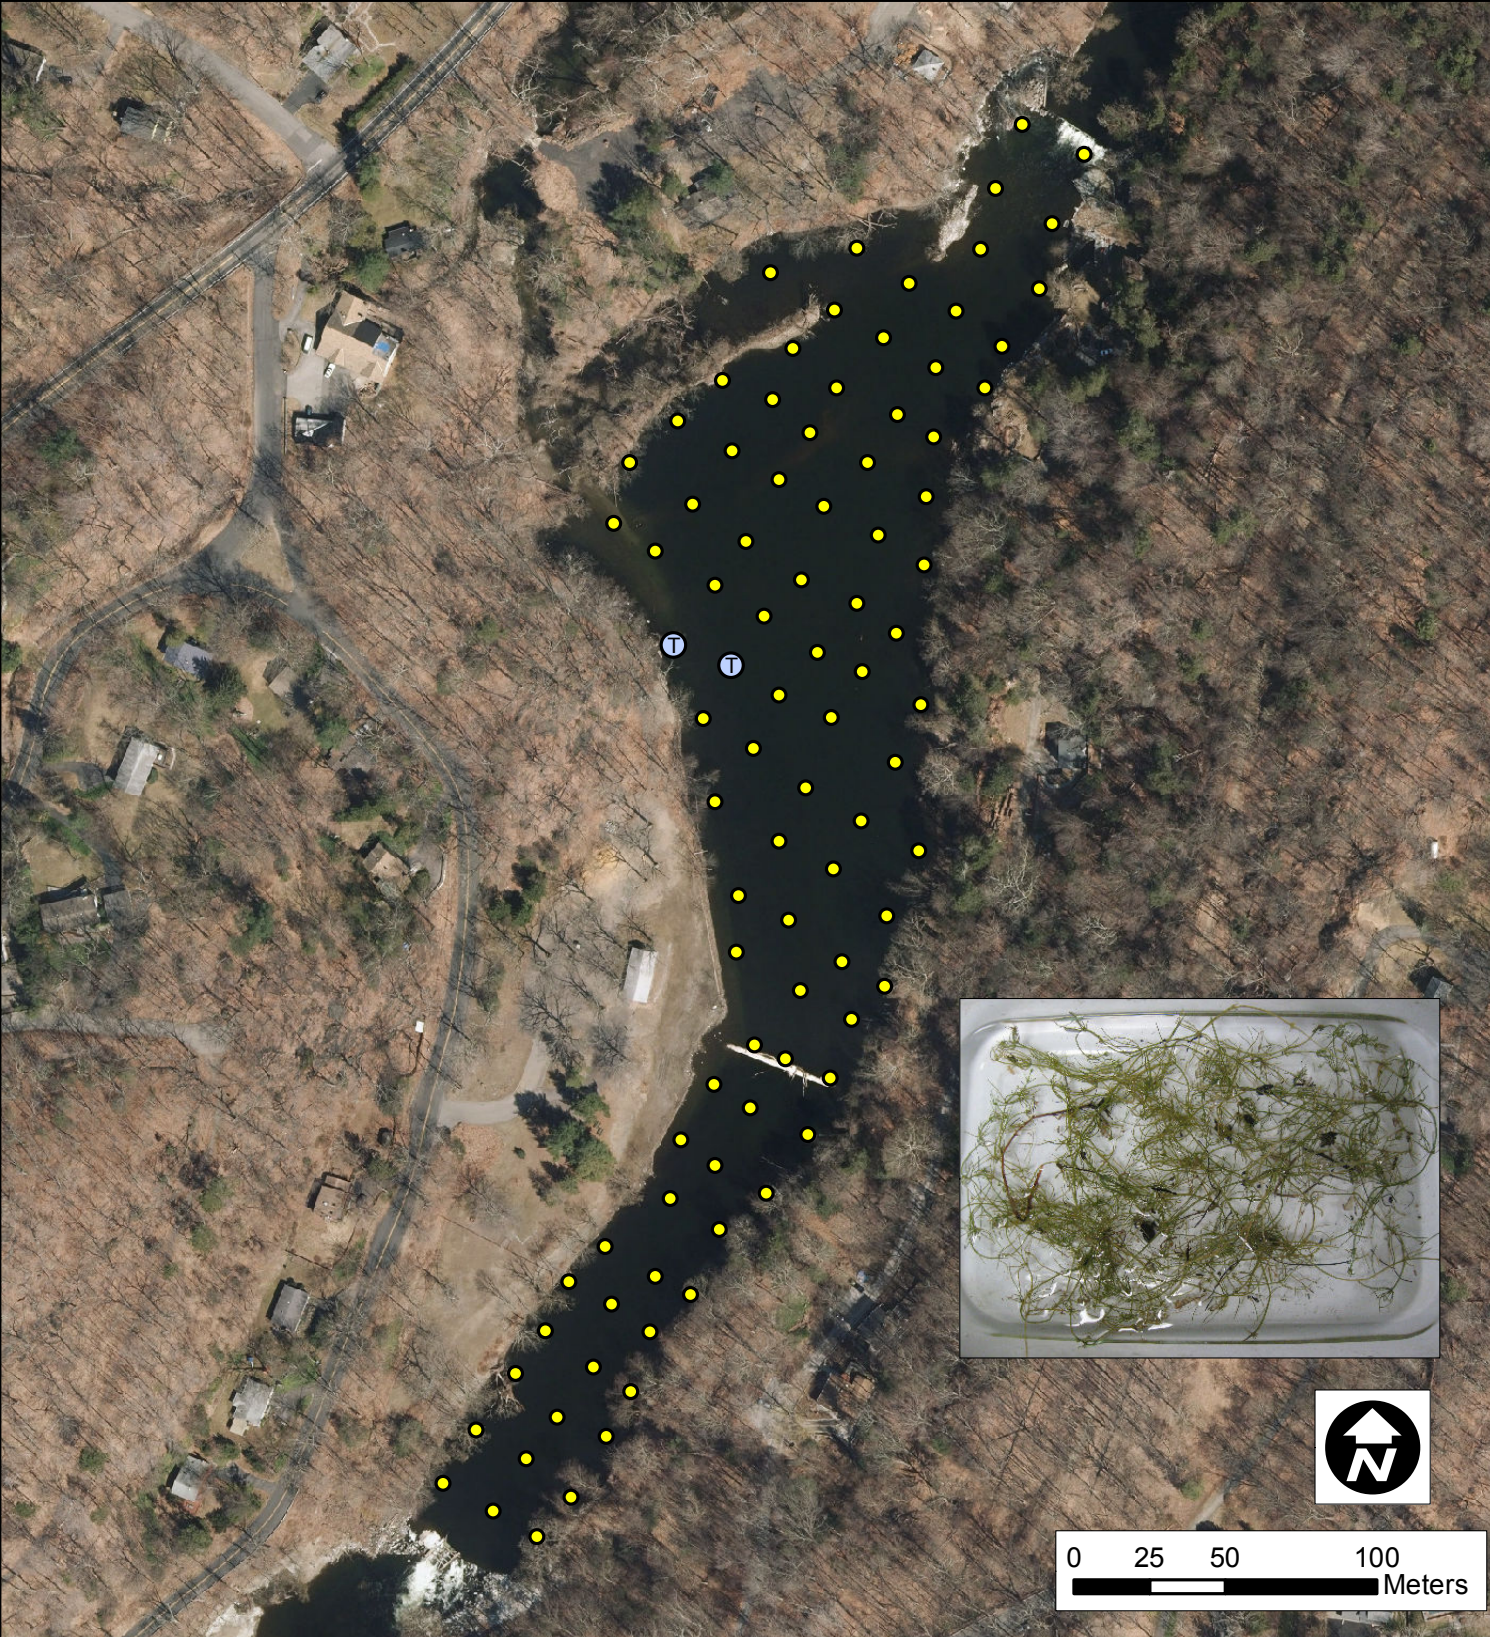
Muskgrass (*Chara species*) Distribution

**Croton River
Section A - Black Rock Park
Aquatic Vegetation Survey
October 04, 2016**
93 Sites

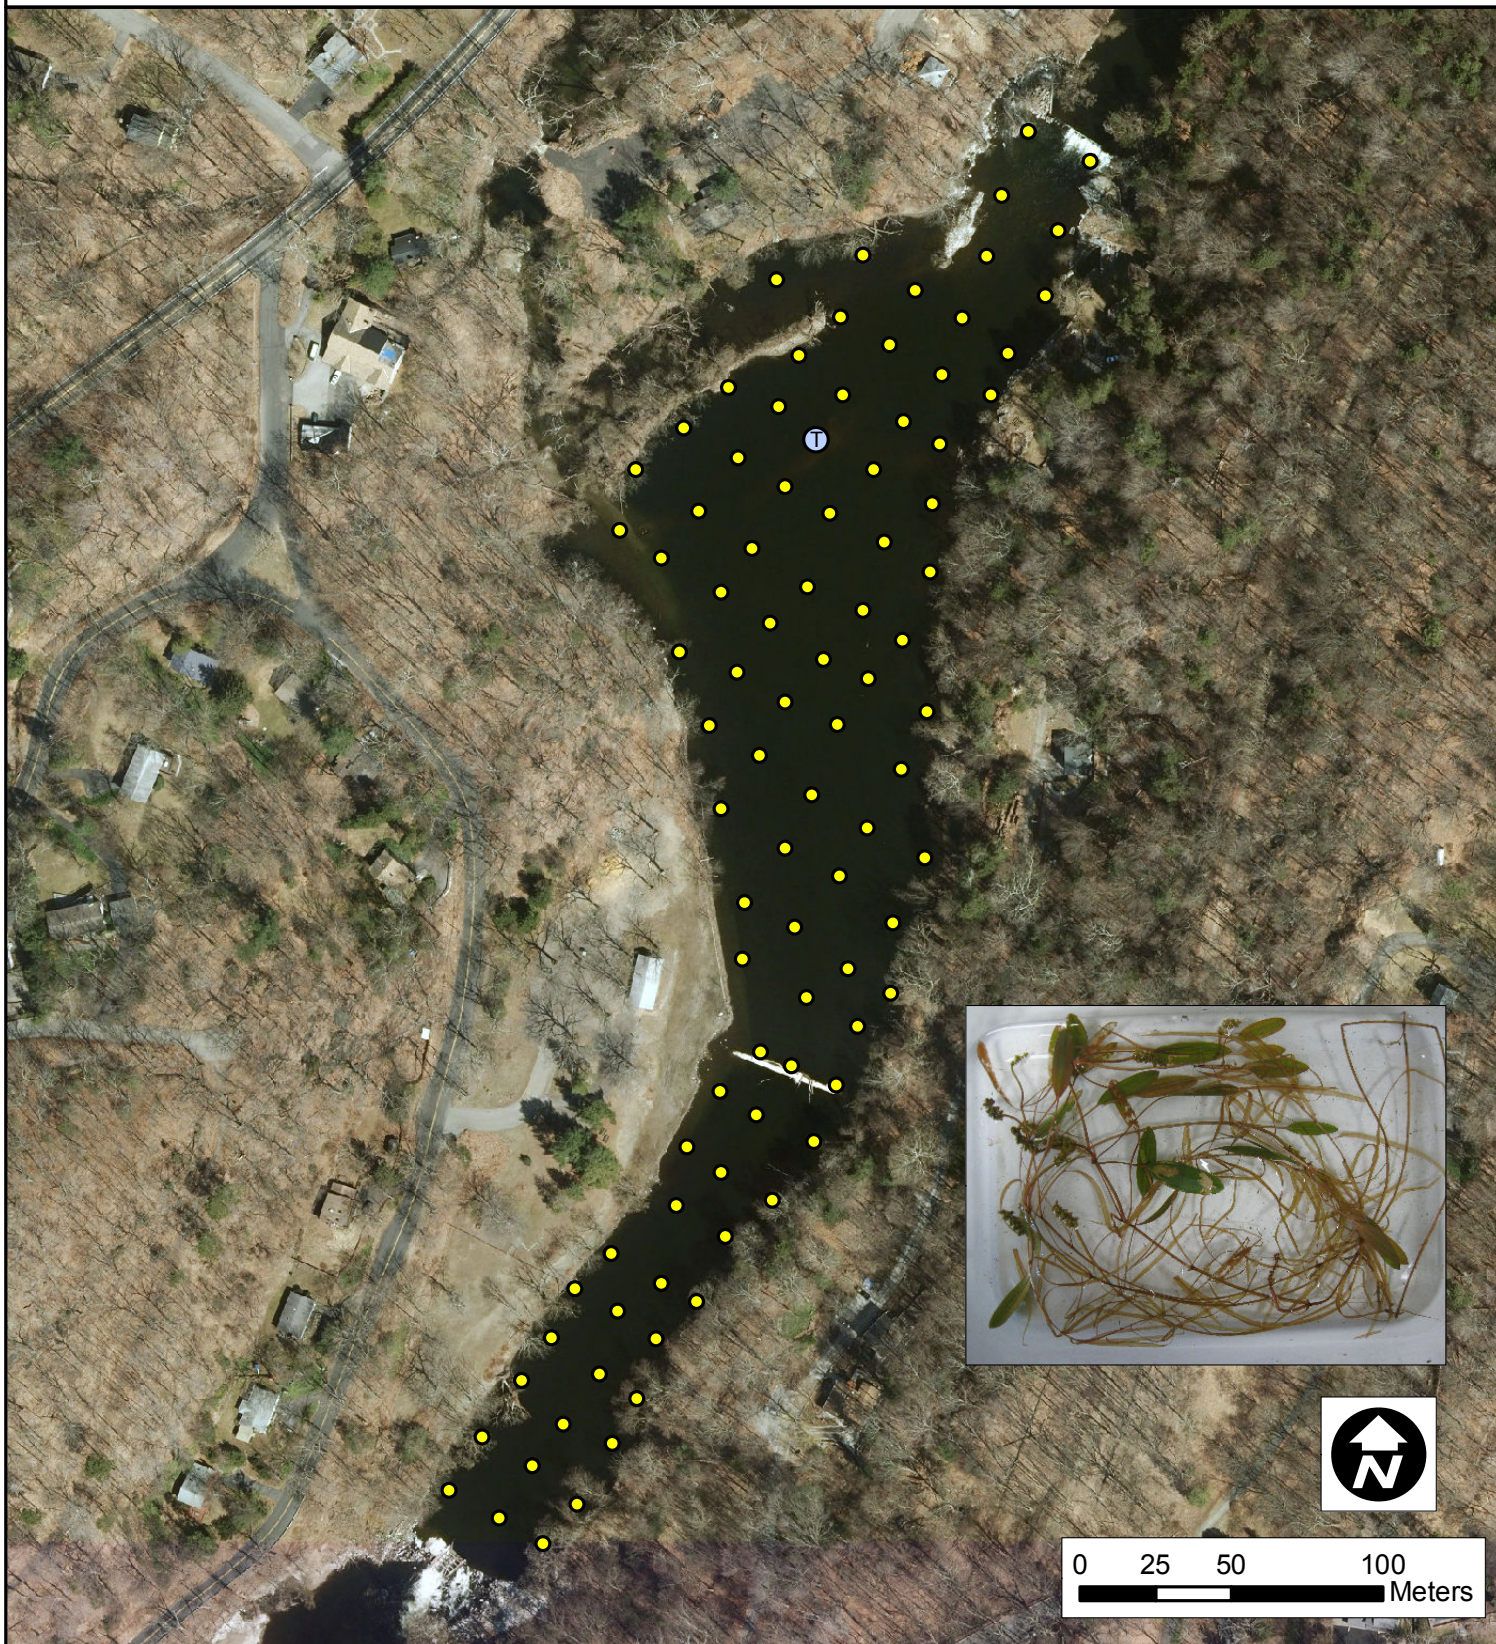
Ribbon-leaf Pondweed (*Potamogeton epihydrus*) Distribution

**Croton River
Section A - Black Rock Park
Aquatic Vegetation Survey
October 04, 2016
93 Sites**

Percent Distribution	Abundance	Sites	Percent
	Total	1	1%
	Trace	1	100%
	Sparse	0	0%
	Medium	0	0%
	Dense	0	0%

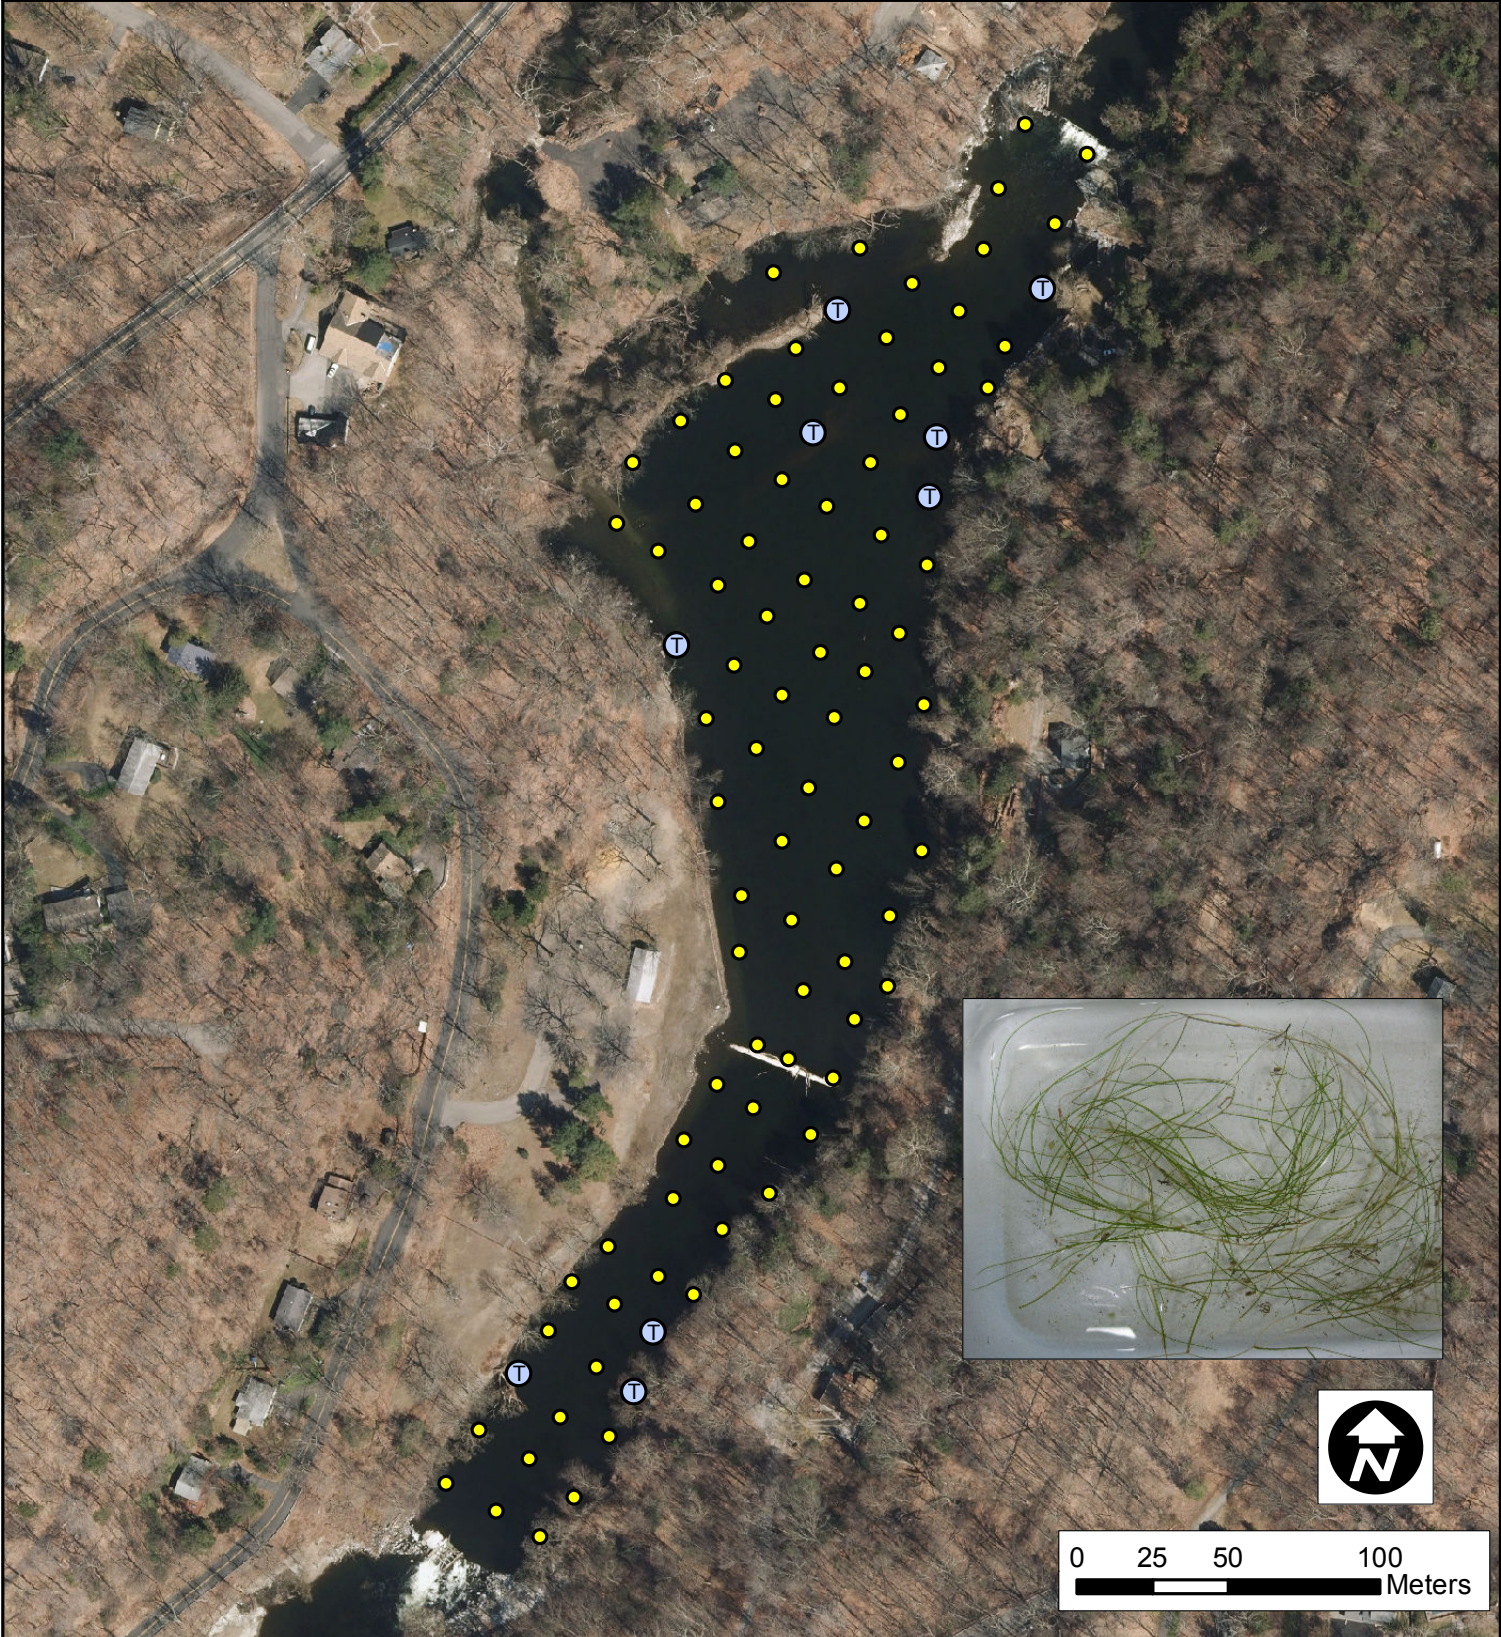
Sago Pondweed (*Stuckenia pectinata*) Distribution

**Croton River
Section A - Black Rock Park
Aquatic Vegetation Survey
October 04, 2016
93 Sites**

Abundance	Sites	Percent
Total	9	10%
Trace	9	100%
Sparse	0	0%
Medium	0	0%
Dense	0	0%
