2016 Delineation of Hydrilla and other Submersed Aquatic Vegetation (SAV) in the Croton River: Black Rock Park

12/15/2016

*Croton River: Black Rock Park
Village of Croton-on-Hudson, Westchester County, New York*

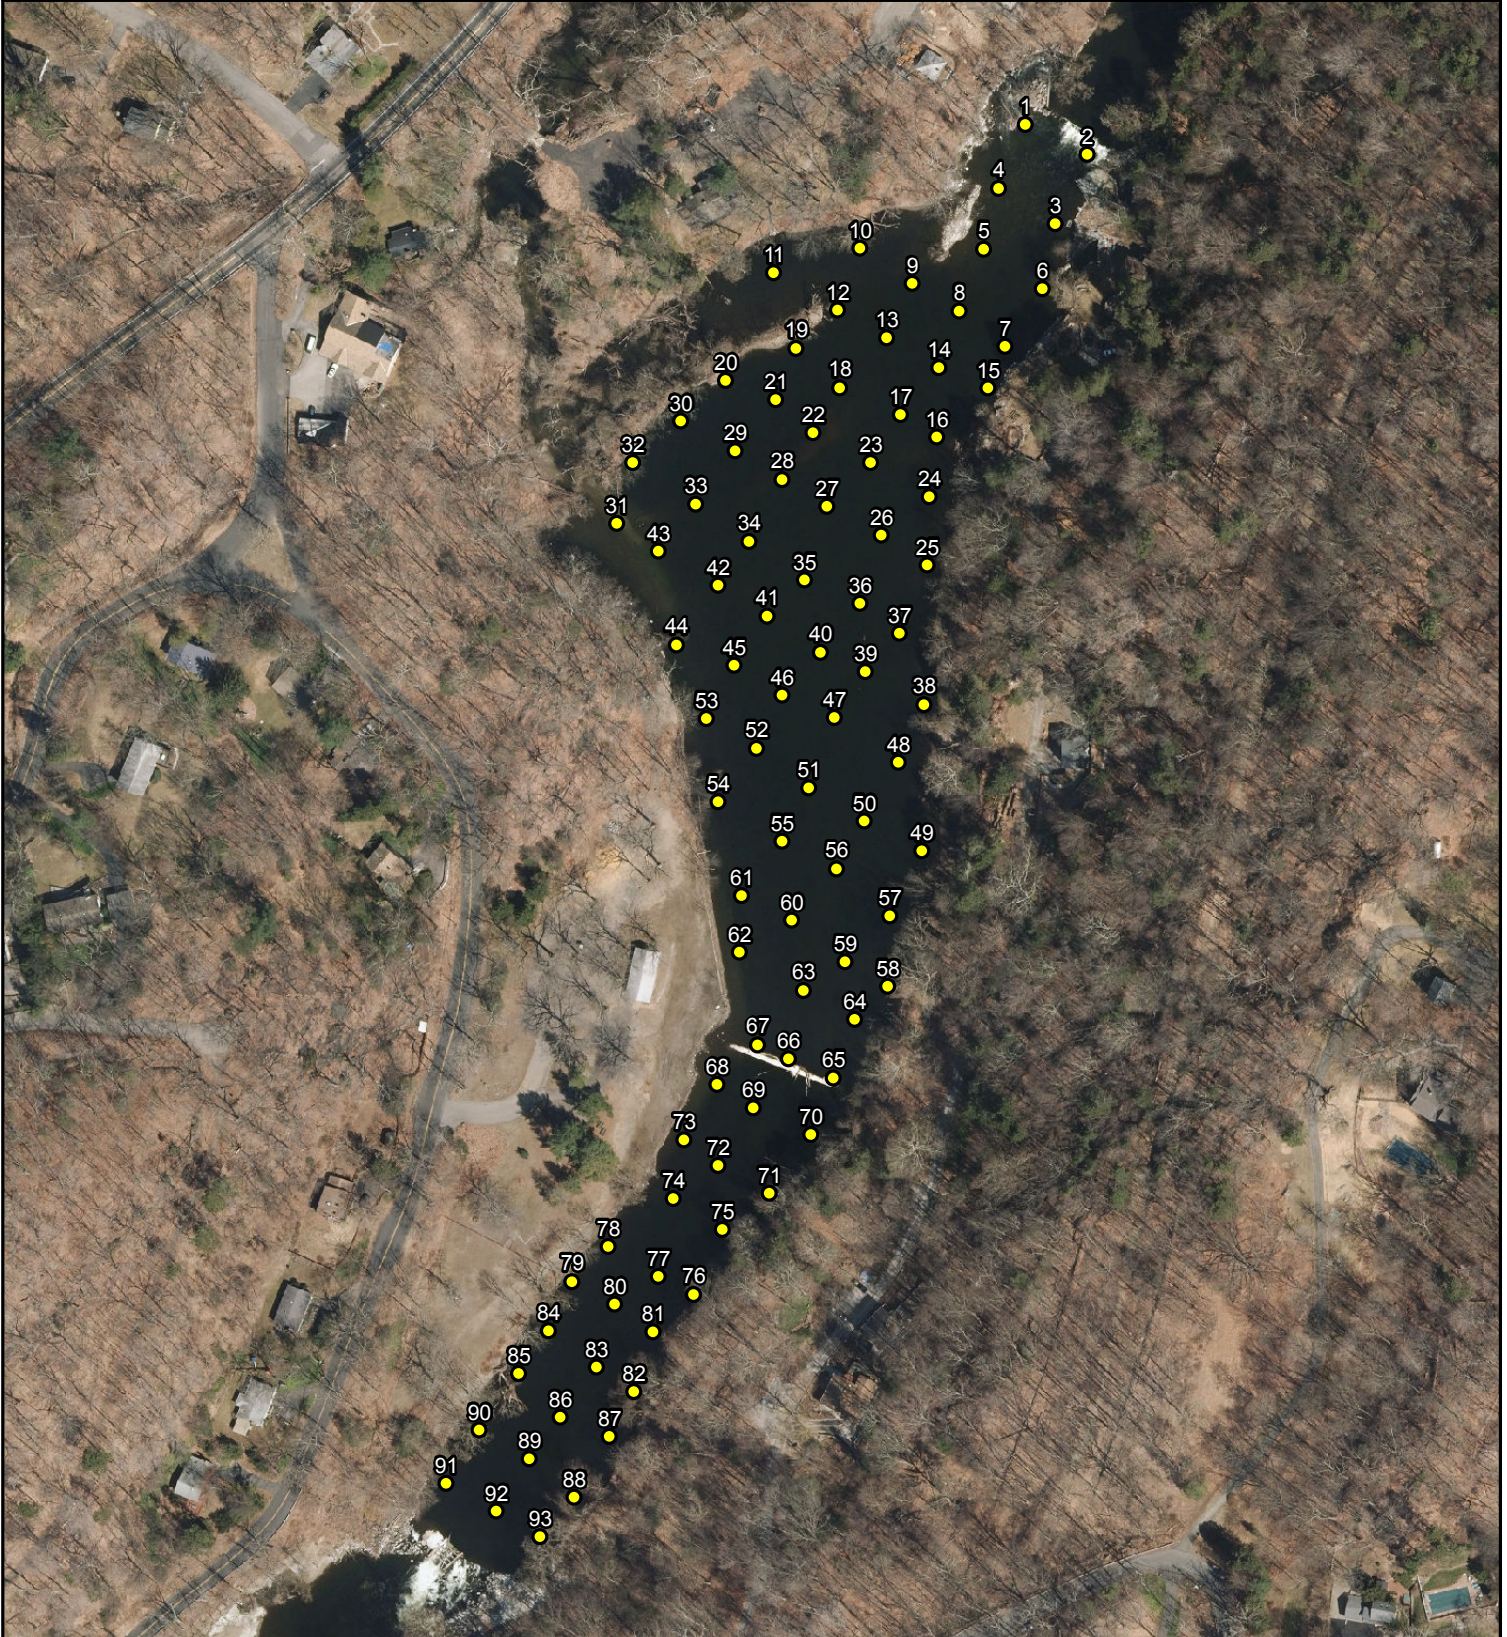
Sample Point Location

Croton River
Section A - Black Rock Park
Aquatic Vegetation Survey
October 04, 2016
93 Sites

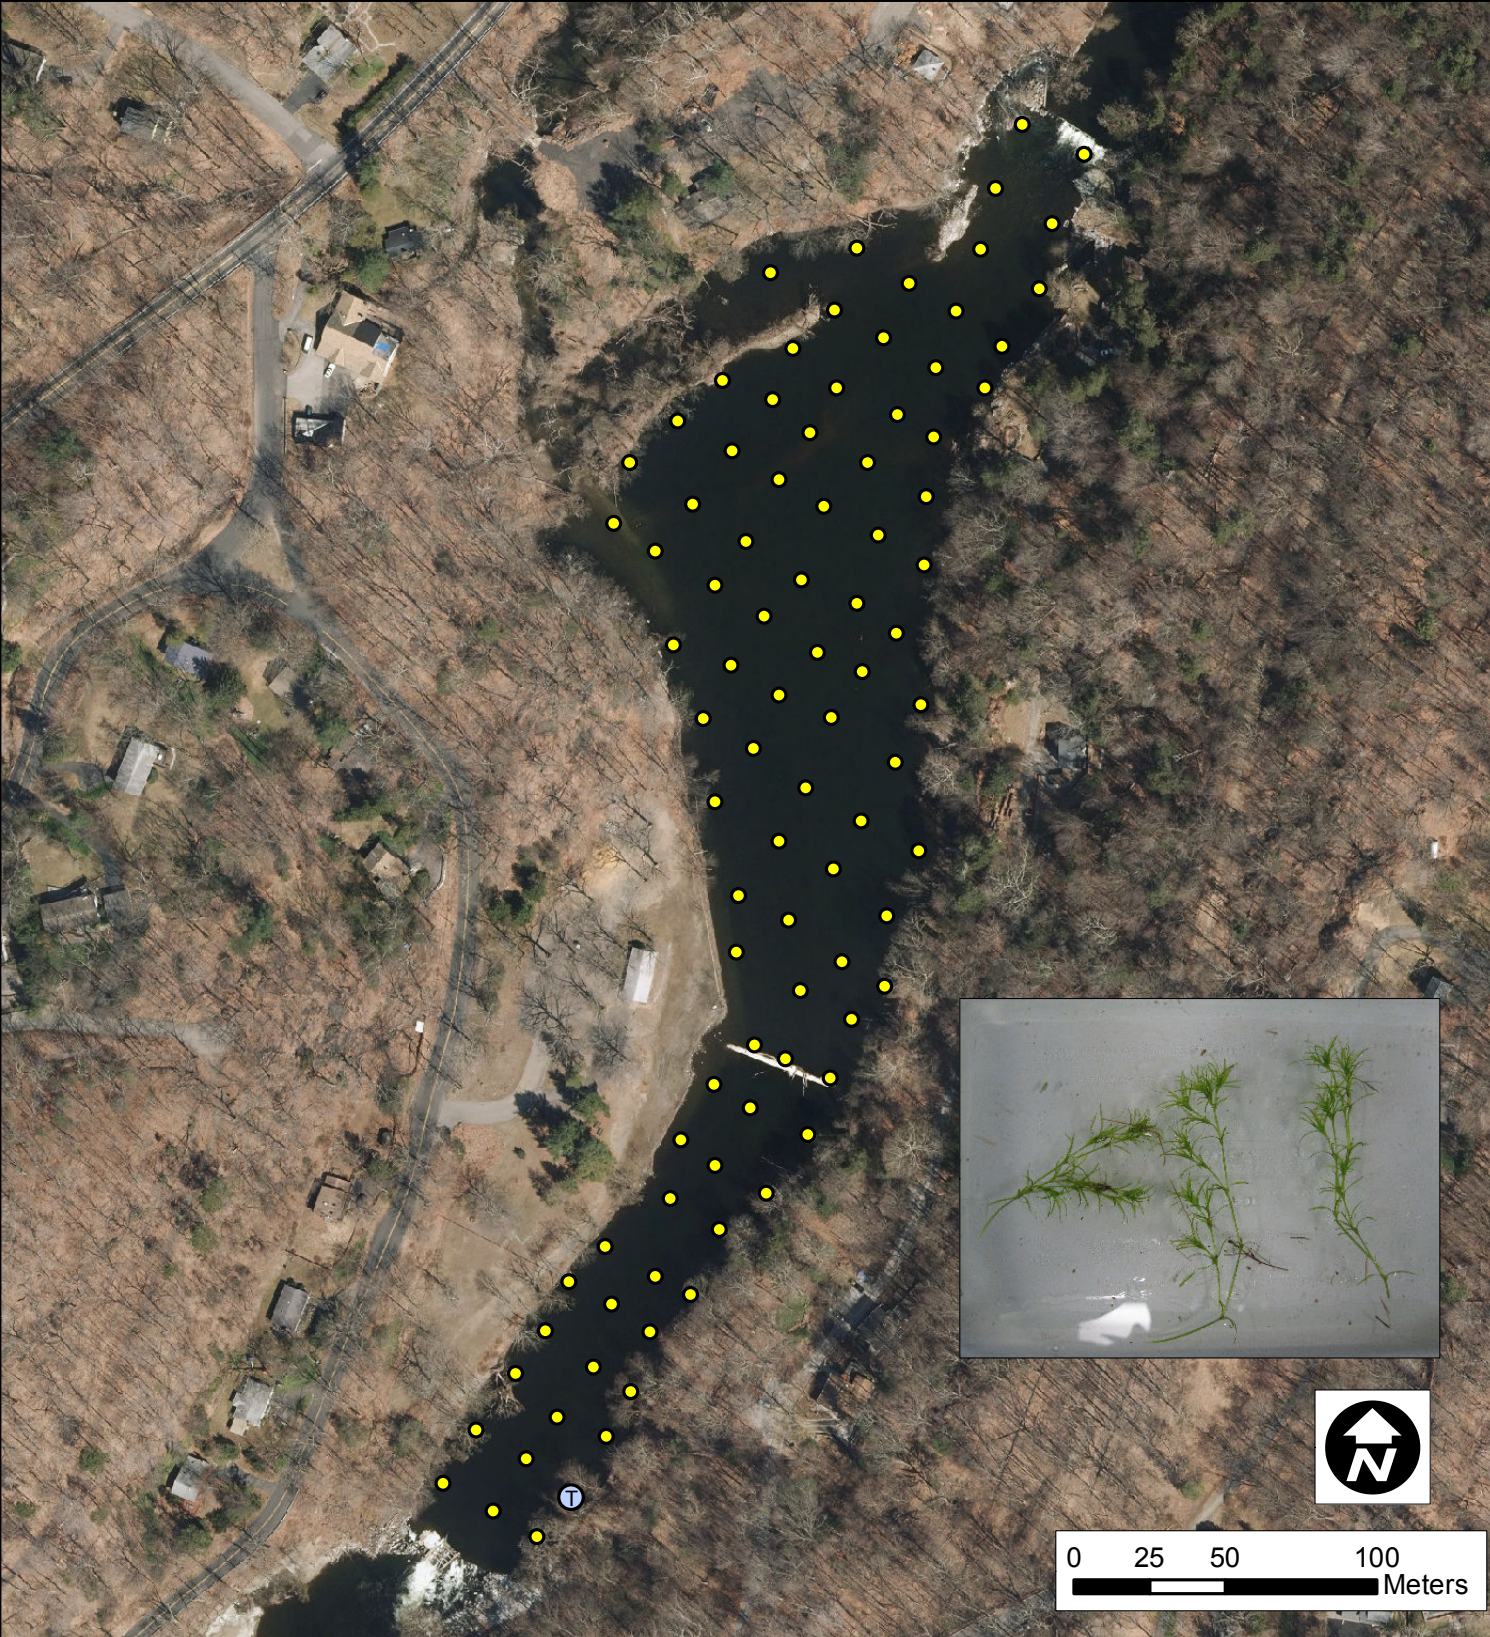
Slender Naiad (*Najas flexilis*) Distribution

**Croton River
Section A - Black Rock Park
Aquatic Vegetation Survey
October 04, 2016
93 Sites**

Abundance	Sites	Percent
Total	1	1%
Trace	1	100%
Sparse	0	0%
Medium	0	0%
Dense	0	0%

Slender Naiad (*Najas flexilis*: Common Names: slender naiad, bushy pondweed. **Native**.): Slender naiad has fine-branched stems that can taper to lengths of one meter, originating from delicate rootstalks. Plant shape varies; sometimes compact and bushy, other times long and slender, depending on growing conditions. The leaves are short (1-4 cm long) and finely serrated (magnification required), tapering to a point. It is found in a variety of habitats, and can colonize sandy or

gravelly substrates. If conditions are ideal, it can reach nuisance densities. It is a true annual, and dies off in the fall, relying on seed dispersal to return the next year. It is an important food source for waterfowl.

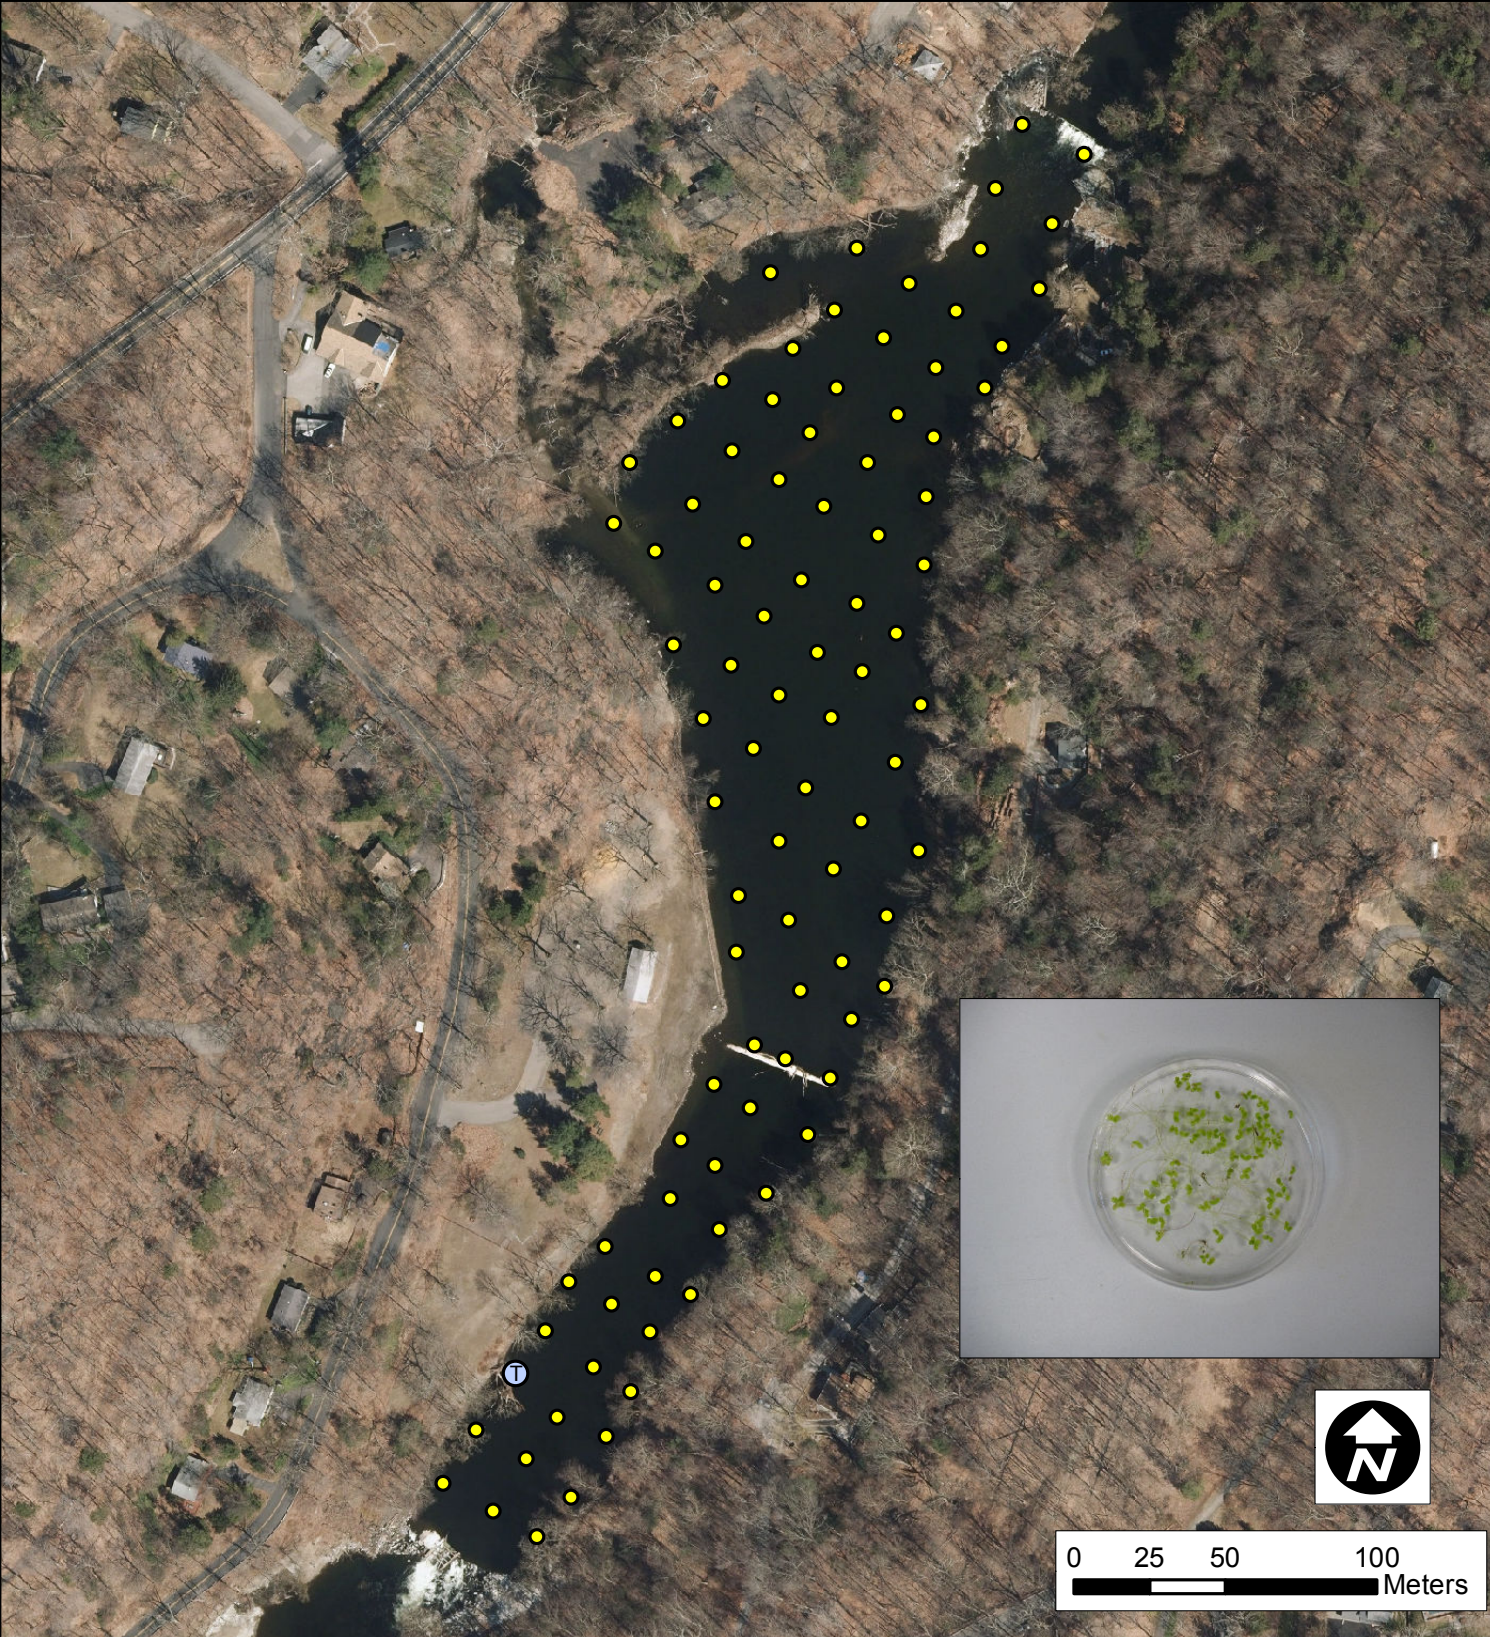
Small Duckweed (*Lemna minor*) Distribution

Croton River
Section A - Black Rock Park
Aquatic Vegetation Survey
October 04, 2016
 93 Sites

Abundance	Sites	Percent
Total	1	1%
Trace	1	100%
Sparse	0	0%
Medium	0	0%
Dense	0	0%

drifts with the wind or water current, and is often found intermixed with other duckweeds. Since it's not attached to the sediment, it derives nutrients directly from the water, and is often associated with eutrophic conditions. It over winters by producing turions late in the season. Small duckweed is extremely nutritious and can provide up to 90% of the dietary needs for waterfowl. It's also consumed by muskrat, beaver and fish, and dense mats of duckweed can actually inhibit mosquito breeding.

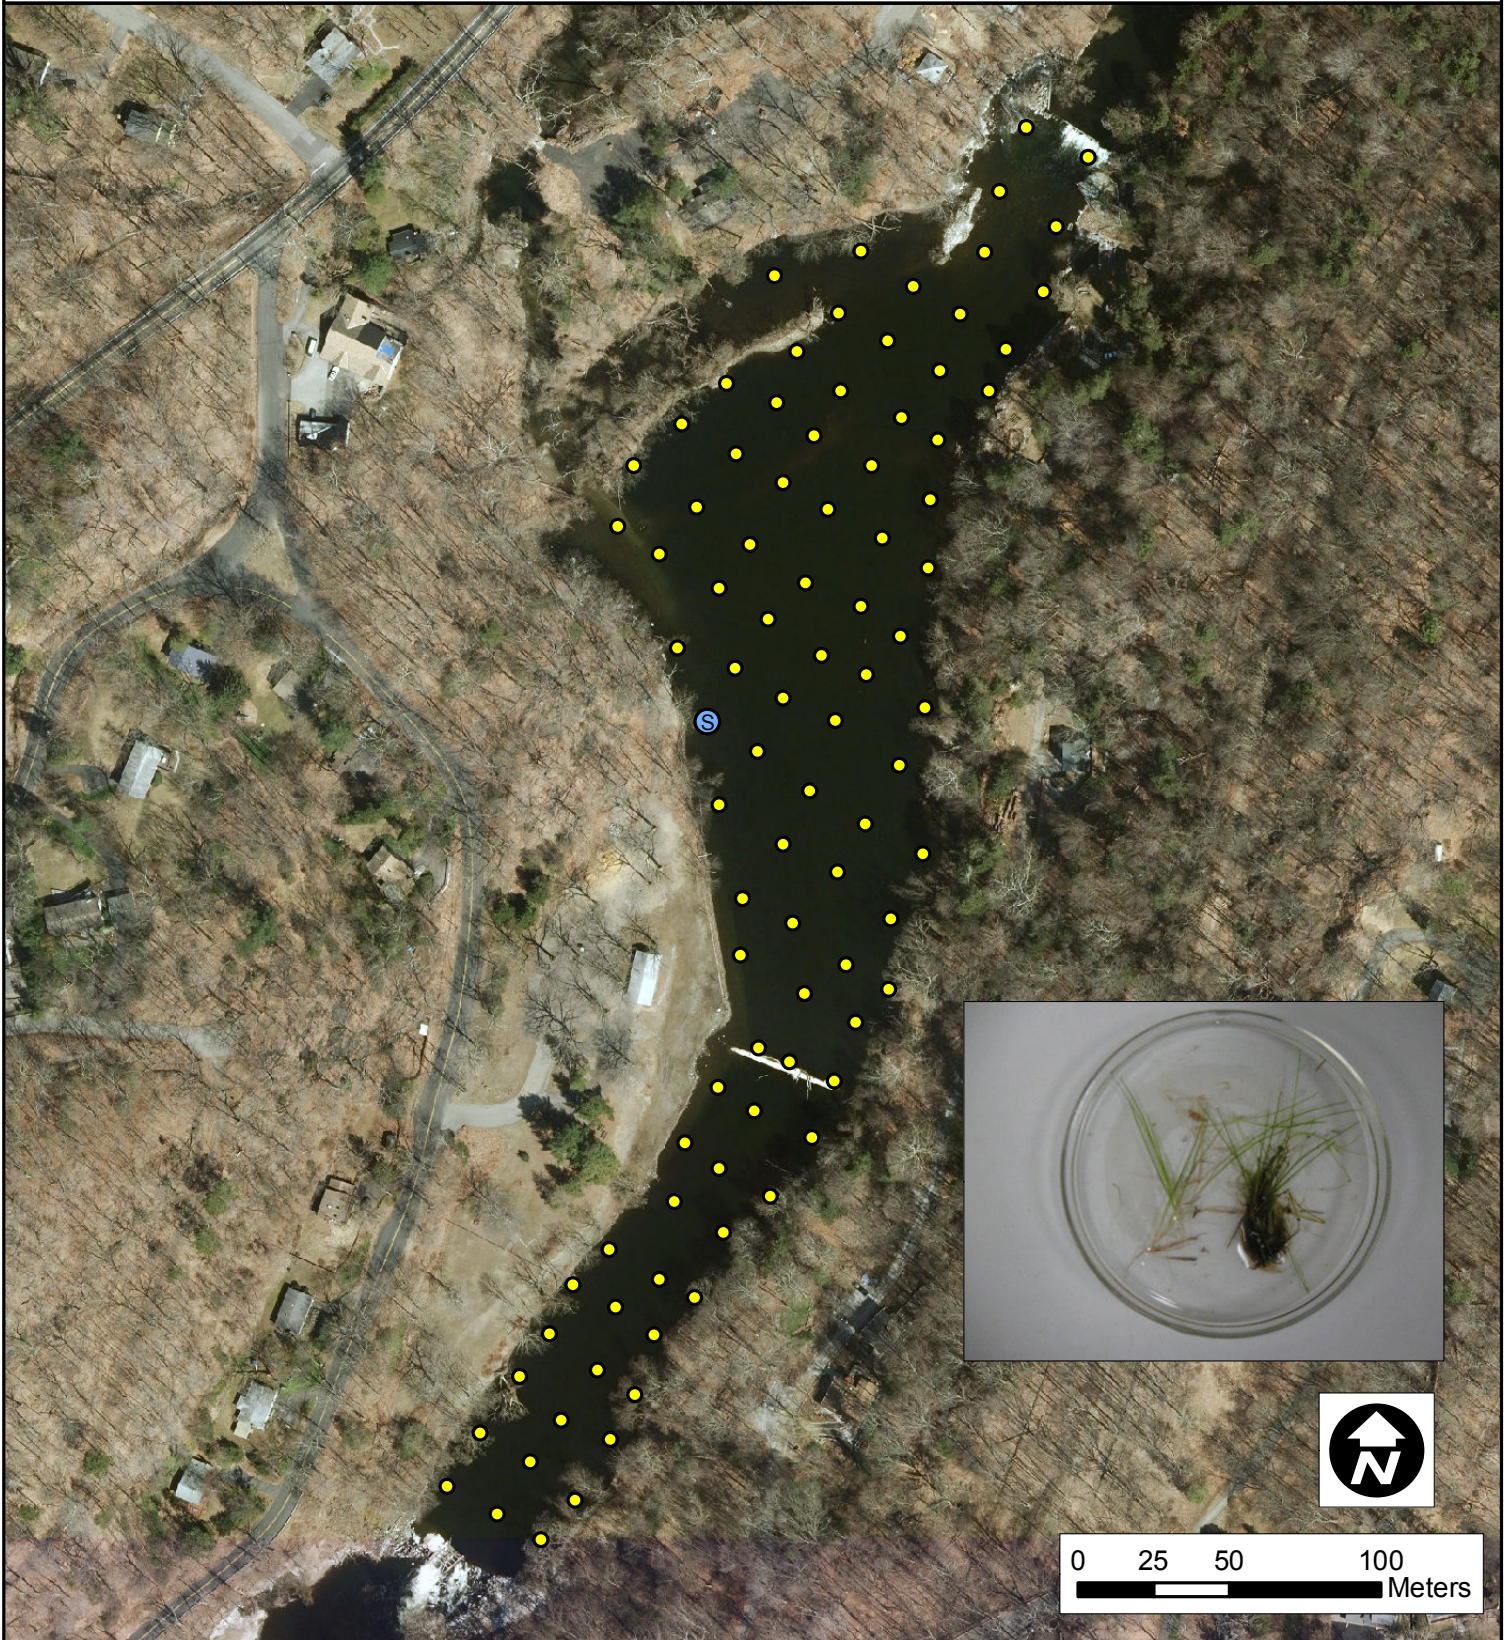
Spikerush (*Eleocharis* sp.) Distribution

**Croton River
Section A - Black Rock Park
Aquatic Vegetation Survey
October 04, 2016**
93 Sites

Percent Distribution	Abundance	Sites	Percent
	Total	1	1%
	Trace	0	0%
	Sparse	1	100%
	Medium	0	0%
	Dense	0	0%

Spikerush (*Eleocharis* sp.: Common Names: hairgrass, spikerush. **Native**.): The stems of spikerush are usually slender and short (up to 12 cm long), that emerge from tufts of fine spreading rhizomes. Sometimes the stems are topped with a spikelet of a tight spiral of flowers and eventually nutlets. The nutlets widely vary in surface patterns, and this characteristic is needed for identification to species level. Spikerush prefers firmer substrates of moist shorelines or into the

water up to 2 meters deep, and can tolerate turbid conditions. The leaves provide suitable food for waterfowl, and excellent habitat and shelter for aquatic invertebrates.

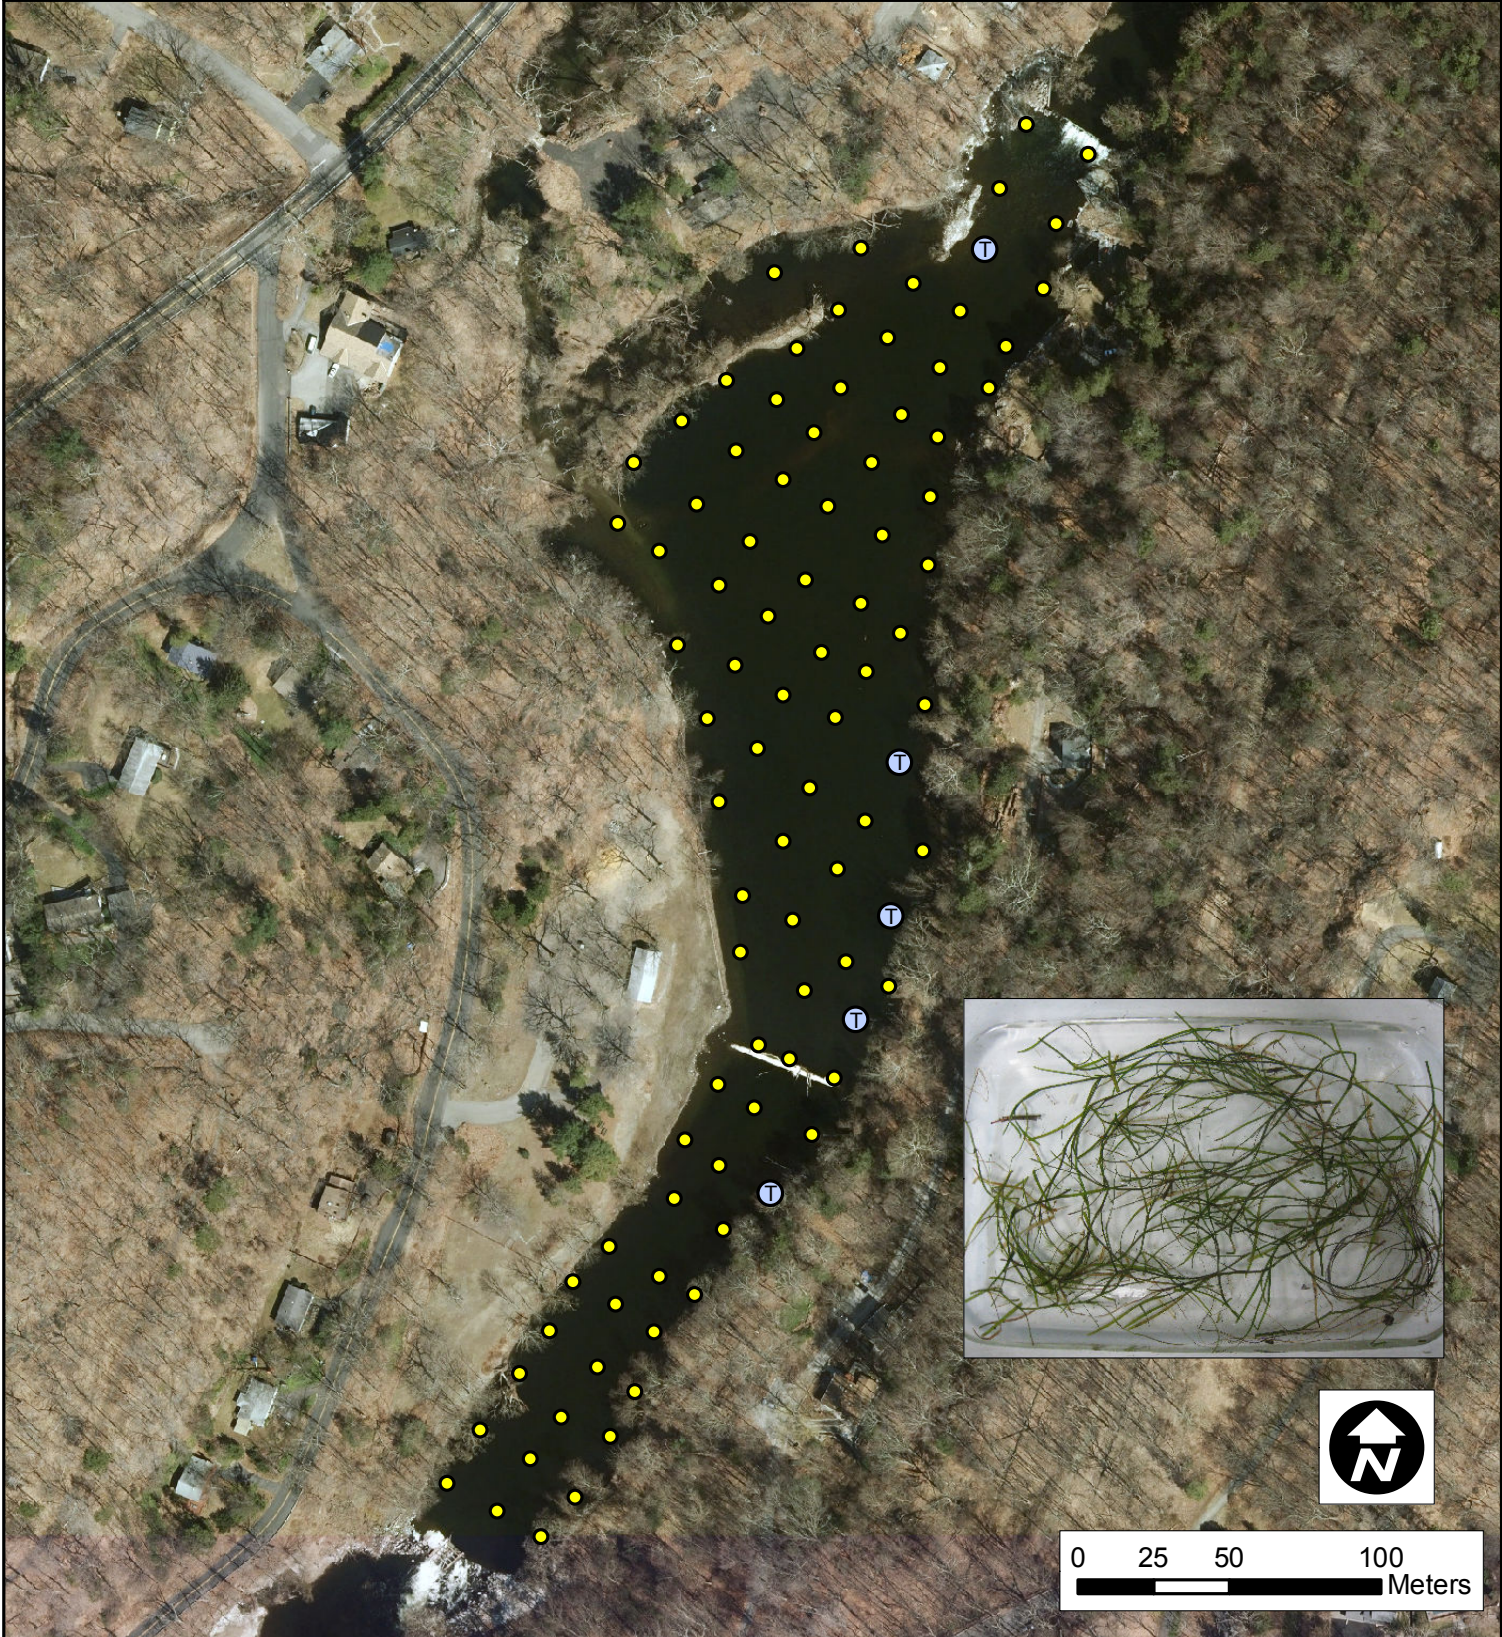
Water Stargrass (*Zosterella dubia*) Distribution

Croton River
Section A - Black Rock Park
Aquatic Vegetation Survey
October 04, 2016
 93 Sites

Percent Distribution	Abundance	Sites	Percent
	Total	5	5%
Trace	5	100%	
Sparse	0	0%	
Medium	0	0%	
Dense	0	0%

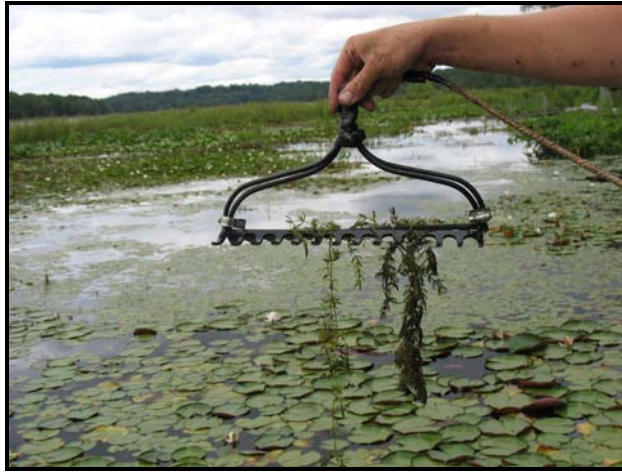
Trace

Submersed Aquatic Plant Density
